FLOOD | DOCTOR
WATER DAMAGE RESTORATION SPECIALIST

TECHNICAL REPORT

The purpose of this visit was to evaluate the moisture levels and carry out a damp and mould survey to the property.

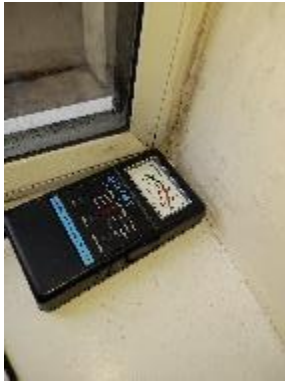
Elevated moisture reading to window board to window in bedroom.

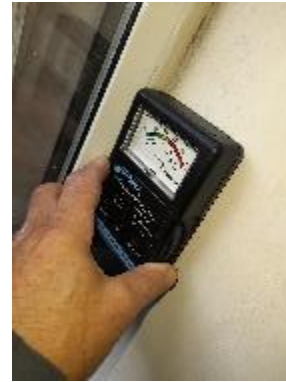
Elevated moisture reading to wall return to window in bedroom

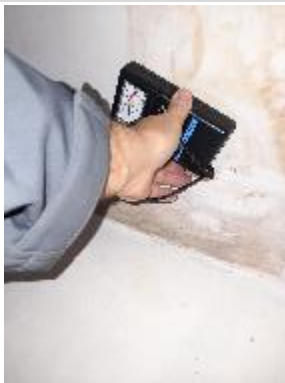
- Visible water damage to part of ceiling, coving and wall covering an area of approximately half square metre. Elevated moisture readings of up to 30% wood moisture equivalent (wme) to the ceiling and upper wall. I understand that water has dripped intermittently from the hole in the ceiling.
- Visible mould growth seen to window board. A small area of the window board had elevated moisture readings of up to 30% moisture content.
- Just above the window board, visible mould growth seen to the wall return to the window. Elevated moisture reading of 25% wme found to this wall.
- Elevated moisture readings found to lower part of wall and skirting beneath the water damaged ceiling. The elevated moisture readings were 30% wme to the wall and 30% mc to the skirting.
- The sub floor to this room is concrete/screed covered with floor laminate.

Water damage to bedroom ceiling.

- The water damage to the ceiling, coving and wall is being caused either by ingress of water from the flat above due to a leak from the en-suite or bathroom. I entered the flat above and at the time of my visit was unable to locate a leak, although there was some visible water damage to the wall by the shower to in the en-suite. The other potential cause of water damage could be due to rainwater ingress through the hole in the external wall above the bedroom.
- Flood Doctor would recommend that the owner of the flat above is asked to run the shower to see if any water enters the bedroom. If no water enters the flat, then the bathroom appliances need to be run to check if any water enters the bedroom. If no water enters the bathroom, then the cause of water damage could be rainwater entering the property through hole in the external wall.

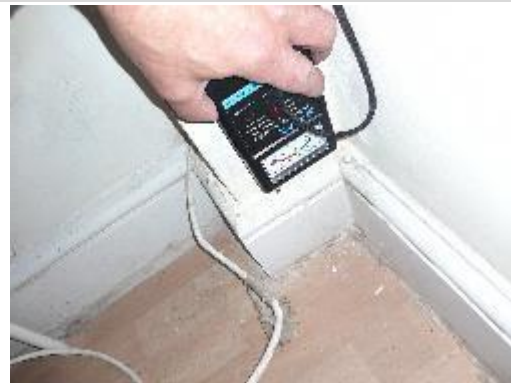
Elevated moisture reading to lower wall in bedroom.

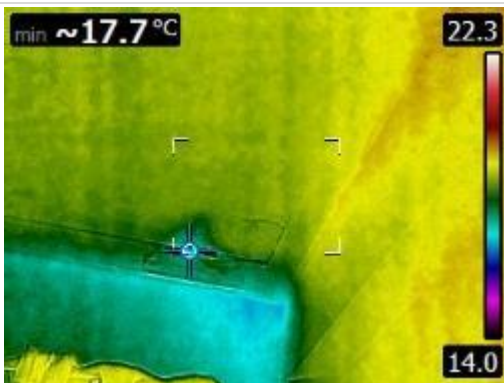
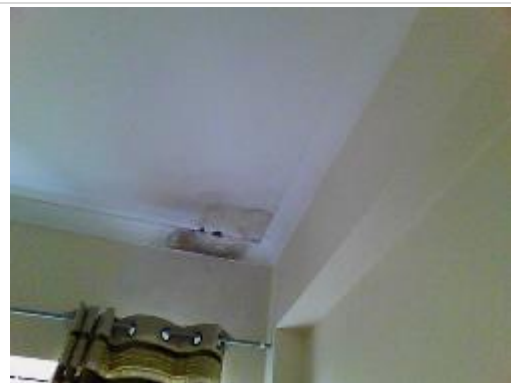
Thermal image of water damaged area of bedroom ceiling, coving and upper wall.

Photo of water damaged area of bedroom ceiling, coving and upper wall.

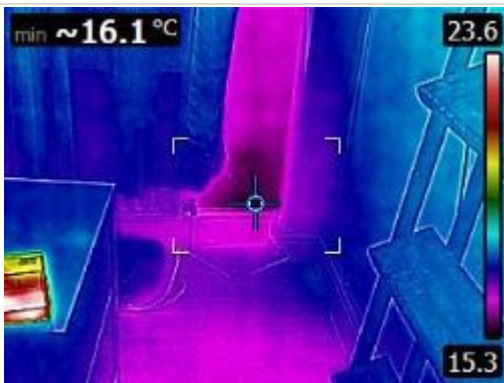
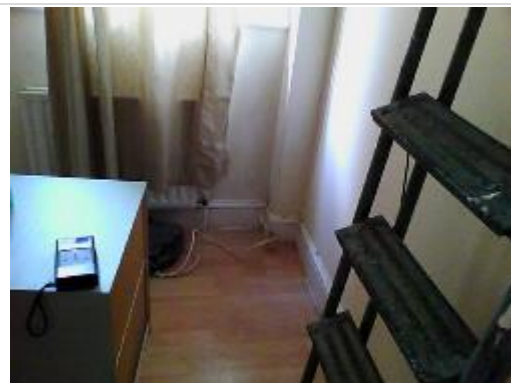
Thermal image of lower part of bedroom wall where elevated moisture readings located.

Photo of lower part of bedroom wall where elevated moisture readings located.

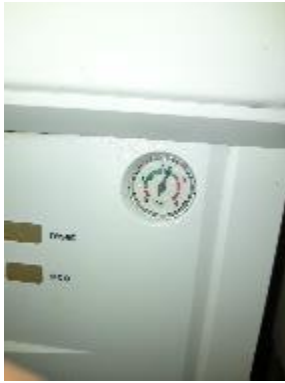
- The extension comprises of a kitchen and bathroom.
- There were no signs of water damage to this area at the time of my visit.
- I checked the combi-boiler and found that the pressure gauge was at zero. I put water into the boiler and took a photo of the gauge which showed the dial at just above 2 bars.
- There are no extractor fans in the kitchen or bathroom.

Boiler gauge showing just above 2 bars after being filled.

- The water pressure to the boiler has dropped to zero which indicates either there is a leak from the pipes or there is a problem with the boiler. Further investigation is required to confirm what the problem is as if a pipe is leaking it is possible that the leak is causing water damage to the property and could be part of the reason for high Relative Humidity in the flat and part of the reason for mould growth.
- As there are no extractor fans fitted it is possible that this is another reason for mould growth within the property. It would be good practice to fit extractor fans, which incorporate humidistats.

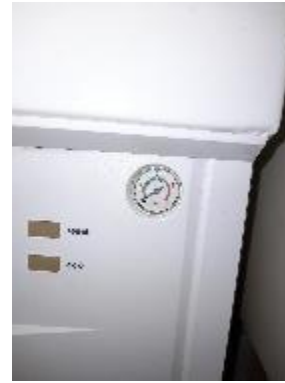
Boiler gauge showing empty after approximately half hour being filled.

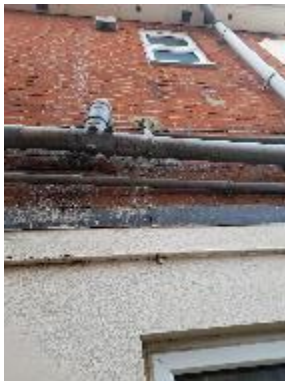
- There is a hole in the brick wall, where a pipe protrudes out, just above the area of water damage to the bedroom ceiling.
- To the front corner of the property there is gutter dripping water onto the pavement just in front of this flat.
- Parts of the air bricks, to the suspended wood floor, are partially blocked.

Hole in brick wall where pipe protrudes out.

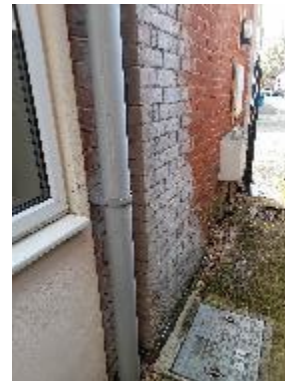
- The external dpc, where visible on the side elevation, is not 150 mm above the external ground. A French gully has been put in place, running along side the brick wall, but this is not 150 mm below the dpc. The French gully does not run off into a drain.
- There was and possibly still is an escape of water from an overflow pipe from above this property as there is large visible water stain on the brick wall.

Water staining to external wall to the outside of the bedroom.

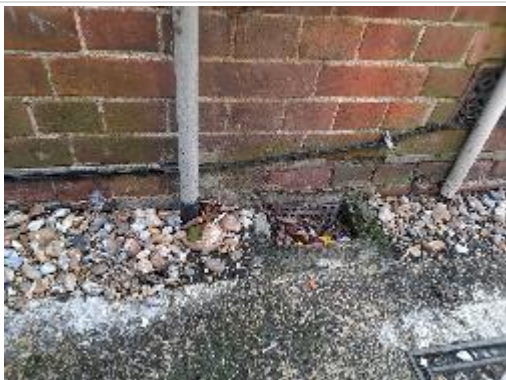
Visible slate dpc just above French gully. Airbrick partially blocked by gravel/debris

- The air bricks need to be cleared of blockages. Air bricks being blocked will prevent air flow to the void and evaporation from the void. The suspended wood floor could then have mould growth and wood decay (wet or dry rot) to the wood floor joists and floorboards.
- The external ground needs to be 150 mm beneath the dpc. It would be good practice to lower the external ground level.

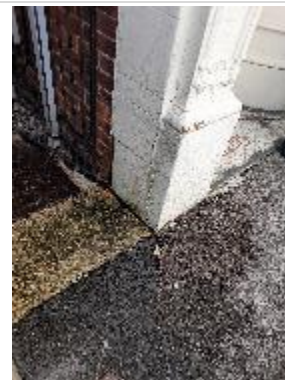
Dripping water from gutter to front corner of the flat.

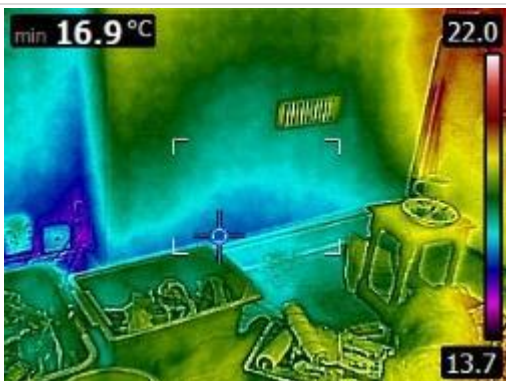
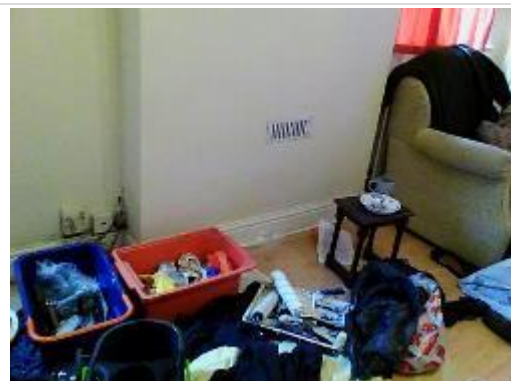
Thermal image of fireplace in lounge/diner showing areas of elevated moisture readings. Blue is area of elevated readings.

Photo of fireplace in lounge/diner showing areas of elevated moisture readings

- The elevated moisture readings to the lower parts of the walls may be due to previous ingress of water due to the dpc being breached or fossil fuel residue around the fireplace.
