FLOOD DOCTOR
WATER DAMAGE RESTORATION SPECIALIST

TECHNICAL REPORT

The purpose of this visit was to carry out a thorough inspection of the property to establish the cause behind outbreaks of abnormal microbial growth in multiple rooms and put forward a remediation proposal and recommendations to prevent further outbreaks.

The property is a one-bedroom flat located on the 2nd floor of a purpose-built block of flats. The exact age of the building is unknown.

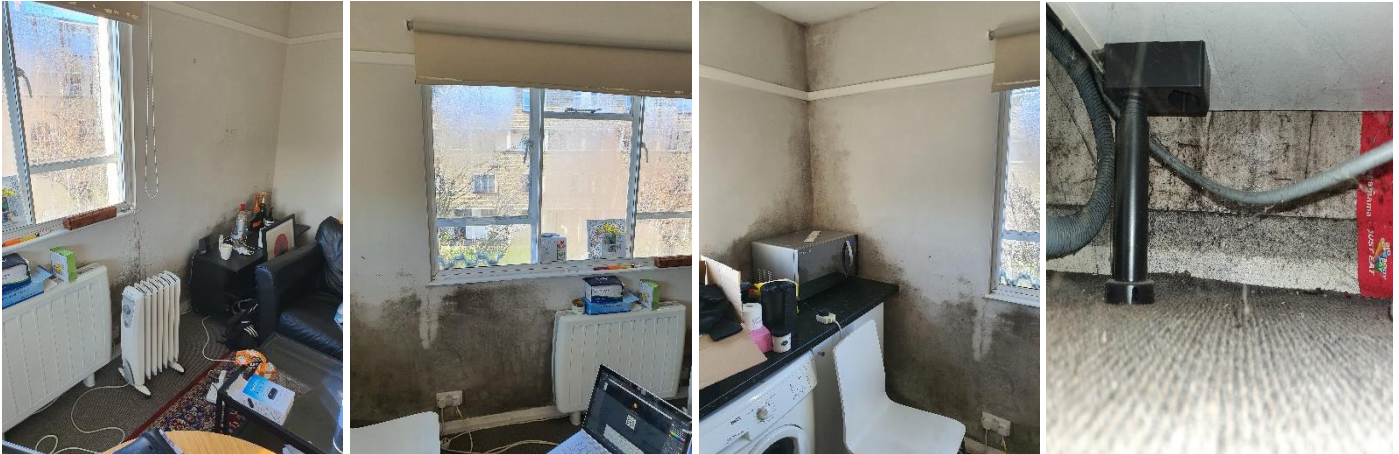
Kitchen/Lounge - Photos

As you can see from the above photos, the open plan kitchen lounge is heavily contaminated with mould, including behind the kitchen units.

In our opinion, the primary reason behind the outbreak of abnormal microbial growth in the kitchen and bedroom is the leak from the kitchen sink. Based on the level of corrosion to the underside of the sink and damage to the underside of the worktop as well as the back of the cupboard, the leak must have been on-going for some time.

- Kitchen units to be removed to facilitate cleaning, sanitation and drying of the walls and floor
- Carpet to be rolled back to facilitate cleaning, sanitation and drying.
- Elec. Radiator to be removed to facilitate cleaning and sanitation of the wall behind
- Skirting boards to be removed from water-damaged walls to facilitate drying
- All exposed surfaces to be cleaned using HEPA vacuum, followed by a chemical wash using a broad-spectrum biocide
- Installation of drying equipment to remove excess moisture from the affected areas

Please note that due to the level of water damage it is unlikely that the worktop and some of the kitchen units will be salvageable.

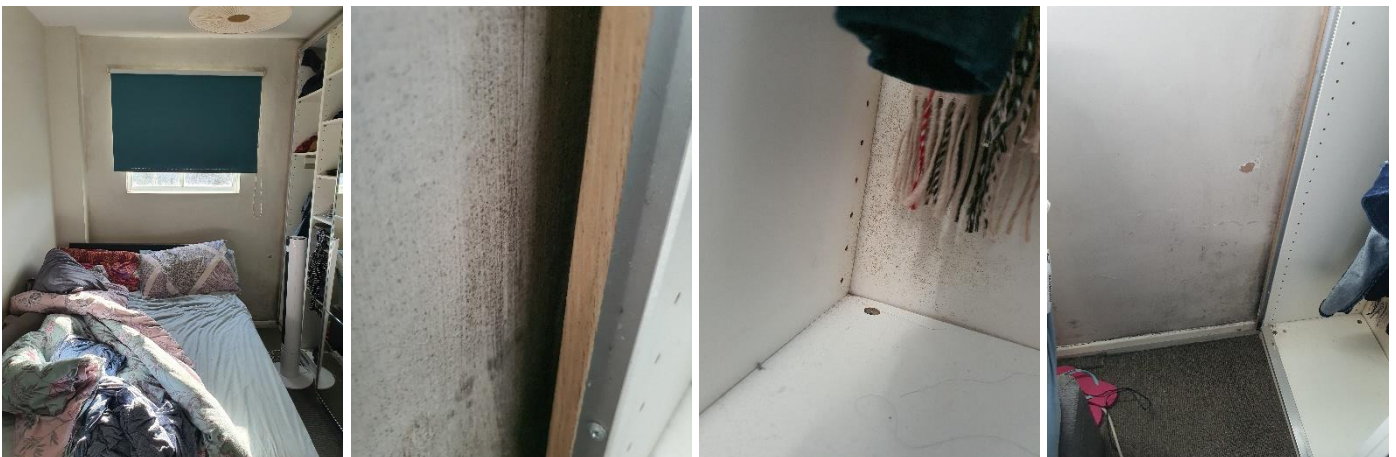
Bedroom

Visible mould contamination to the entire external wall, most of the contamination appears to be located behind the wardrobe which is situated along the partition wall dividing bedroom and kitchen. Back of the wardrobe is also showing signs of mould contamination.

- Cleaning and sanitation of the affected surfaces
- Removal of skirting boards from the affected walls
- Installation of targeted drying regime to remove excess moisture from the affected walls and floor

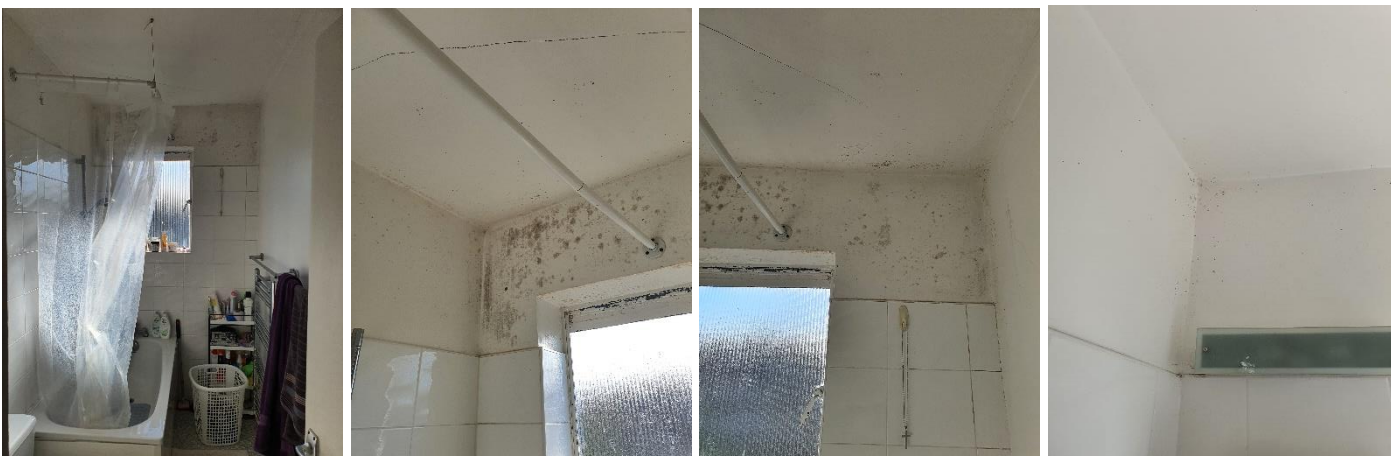
Bathroom

Visible mould contamination mainly around the window although partition wall dividing bathroom and hallway has also been affected to a lesser extent.

In our opinion, the outbreak of abnormal microbial growth in the bathroom is not related to the issues affecting the kitchen and bedroom. The bathroom has no extractor fan or a vent and only a single glazed window. This would lead to a build-up of condensation and humidity levels in this room, which resulted in the outbreak of mould growth over time.

- Cleaning and sanitation of the affected surfaces

- Replacing existing windows with double glazed windows with trickle vents
- Installation of an extractor fan in the bathroom
- Replacing faulty kitchen hood

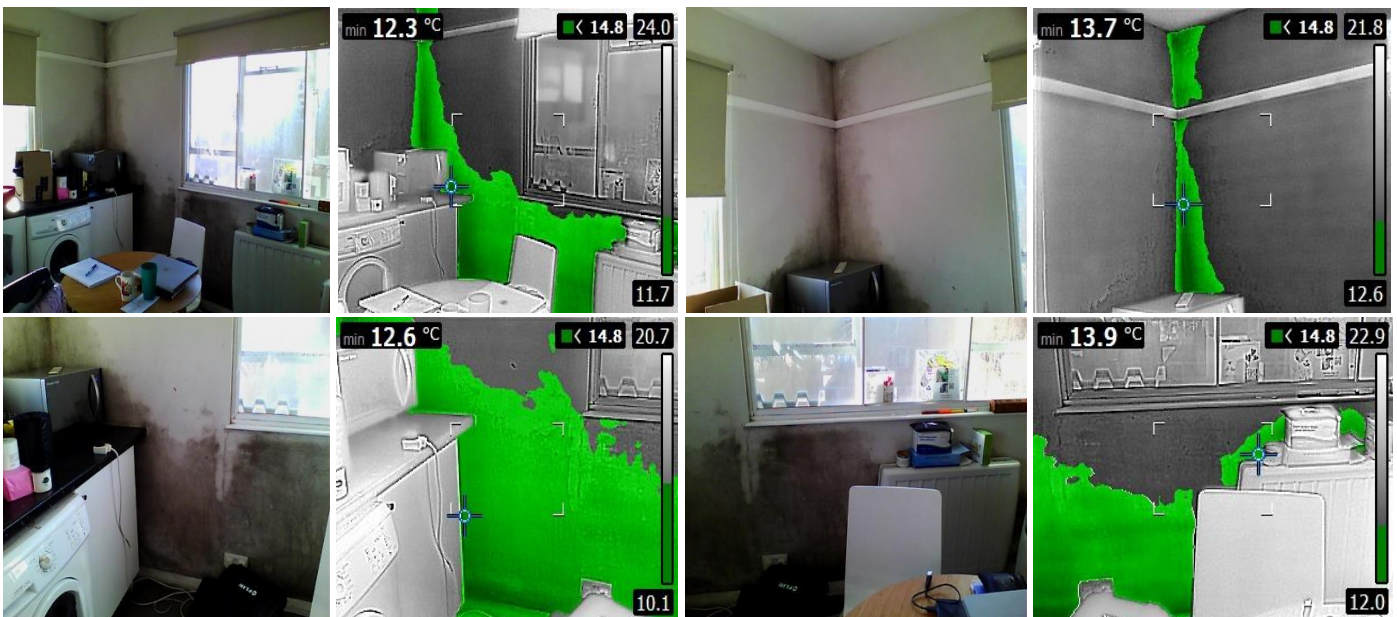
Kitchen / Lounge

Water is detected with a thermal imager due to temperature differences caused by evaporation, capacitance, or conduction.

A “wet” building materials will be cooler than surrounding “dry” building materials. Therefore wet building materials may be more prone to condensation due to lower temperature. In this case, we have found that a large section of the external wall appears to be at risk of condensation however upon closer inspection we have noted that the walls, skirting boards and the floor along the affected walls are wet.

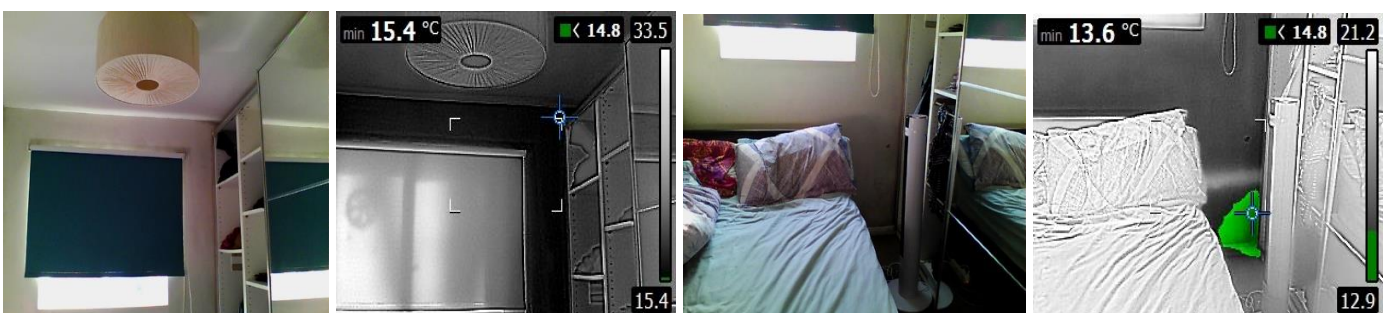
Bedroom

Similarly, as in the bathroom at the time of our visit, the only area which showed as at risk of condensation was a lower wall behind the wardrobe. In our opinion, there are several factors behind the outbreak in this area:

1. A leak in the adjacent kitchen due to faulty seal around the sink. More information about this in the Moisture Survey section of this report.
2. The wardrobe is restricting air circulation in this area; this leads to a build-up of condensation on the wall, which contributed to some extent to the outbreak of mould growth in this room.
3. A single glazed window which is prone to condensation
4. Roller blind which is restricting airflow through the window vent

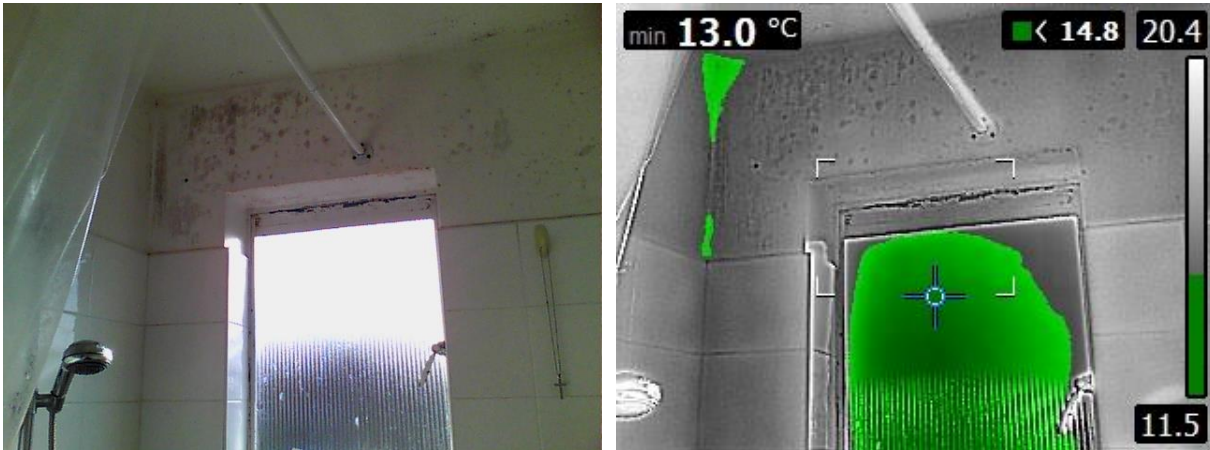
Bathroom

At the time of our visit, the only areas prone to condensation in the bathroom were a window and a small section of the wall in the corner. This indicates that the outbreak of mould in this area is most likely due to a single glazed window and lack of extractor fan.

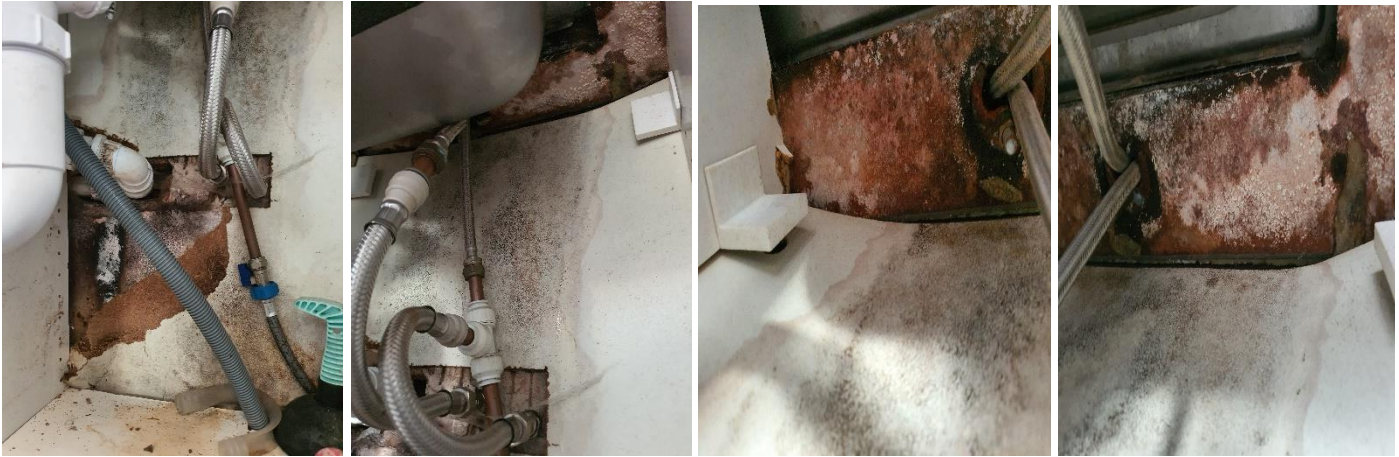
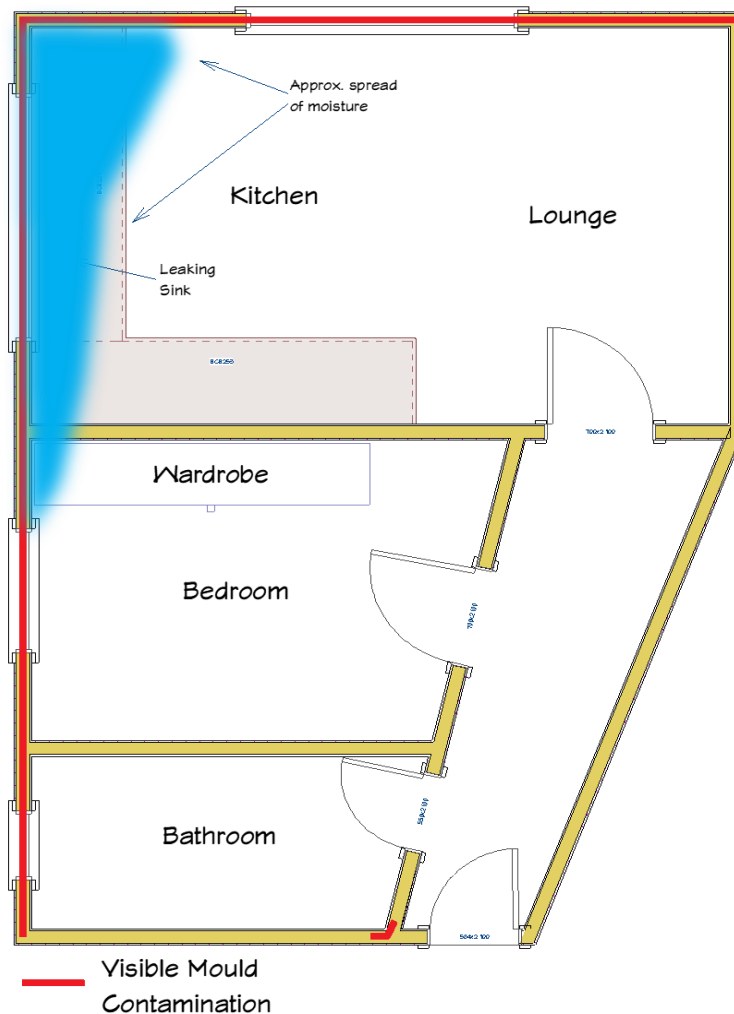
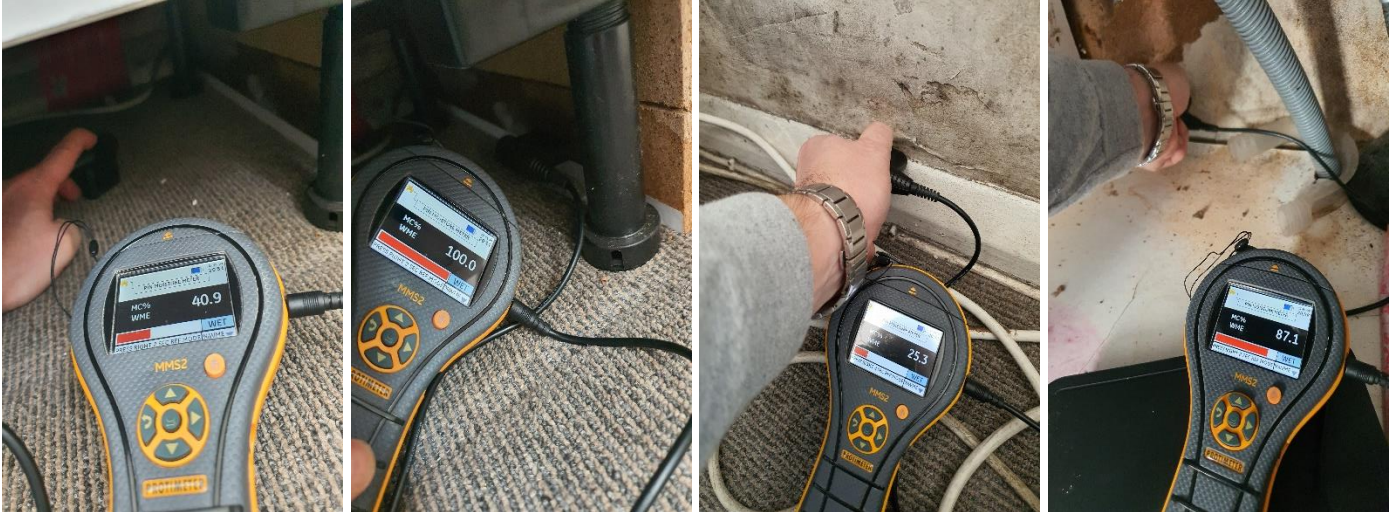
As part of our survey, we have taken a number of moisture readings throughout the property. We have found a leak from the kitchen sink during this part of our investigation.

Please note that the leak is relatively small; however every time the sink is in use a small amount of water is penetrating below the worktop and behind the kitchen units. Furthermore, the leak was impossible to notice without removing all of the contents of the cupboard below the sink.

As you can see from the above photos at the time of our visit, we have recorded elevated to very high moisture readings on the lower external wall, floor, base cupboard side panel (which is water stained), and back of the sink cupboard.
