FLOOD | DOCTOR  
WATER DAMAGE RESTORATION SPECIALIST

# REMEDICATION & REINSTATEMENT PROPOSAL

Surveyed property		Customer details		Flood Doctor	
[REDACTED]		[REDACTED]		<i>(office annotations)</i>	
[REDACTED]		[REDACTED]		Your ref.	N/A
[REDACTED]		[REDACTED]		Our ref.	P-2020/014
[REDACTED]		[REDACTED]		Assessor	Pawel Szczepaniak
[REDACTED]		[REDACTED]		Survey date	4 <sup>th</sup> January 2020
[REDACTED]		[REDACTED]		Time	11:05
Postcode	[REDACTED]	Postcode	[REDACTED]	Estimate Date	9 <sup>th</sup> January 2020

The purpose of this visit was to evaluate the damage in the property following EOW incident from apartment 9, which is located directly above and to prepare drying & reinstatement proposal.

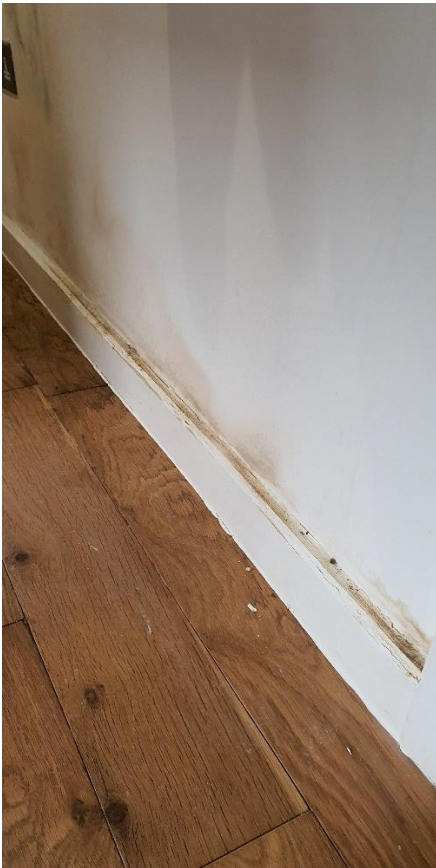
**Hallway – Water damage to the skirting board and lower wall.**

- Mould contaminated plasterboard to be removed from the affected walls (see attached floorplan with locations). Full height on the wall dividing hallway and bathrooms and up to 500mm high on the wall dividing hallway and office.
- Skirting boards to be removed
- Engineered flooring to be uplifted and disposed of
- Chipboard floor to be inspected and removed if necessary
- Sub-floor void to be inspected and sanitised using a broad-spectrum biocide
- All exposed building materials to be cleaned and sanitised using anti-microbial or broad-spectrum biocide depending on the level of contamination

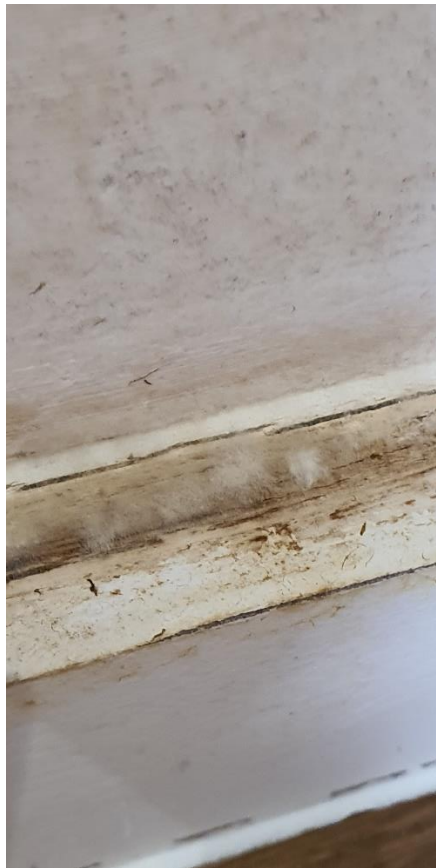
**Microbial growth present on the surface of the skirting board.**

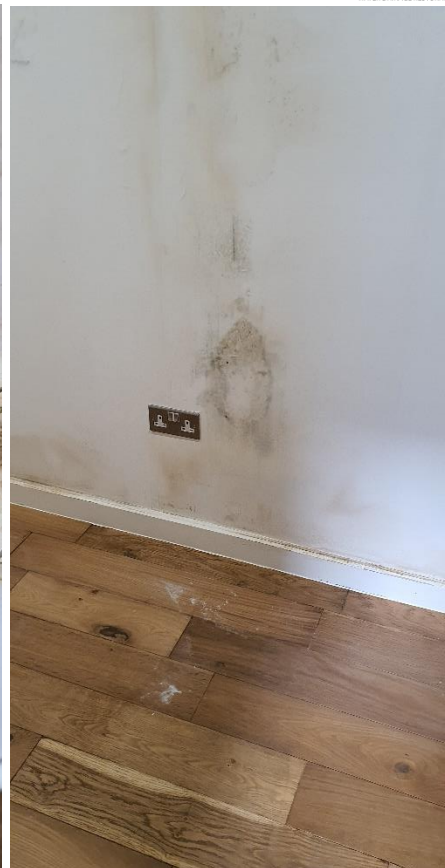
**Microbial growth present on the surface of the plasterboard.**

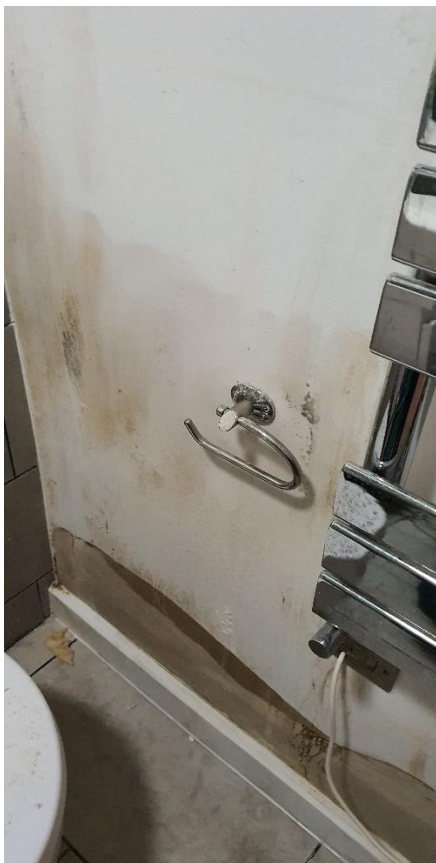
**En Suite – Water damage to the lower wall.**

- Sanitary units to be removed and stored on-site for re-use
- Tiles to be stripped from the affected walls and floor
- Chipboard floor to be removed if necessary
- Sub-floor void to be inspected and sanitised using a broad-spectrum biocide
- All exposed building materials to be cleaned and sanitised using anti-microbial or broad-spectrum biocide depending on the level of contamination

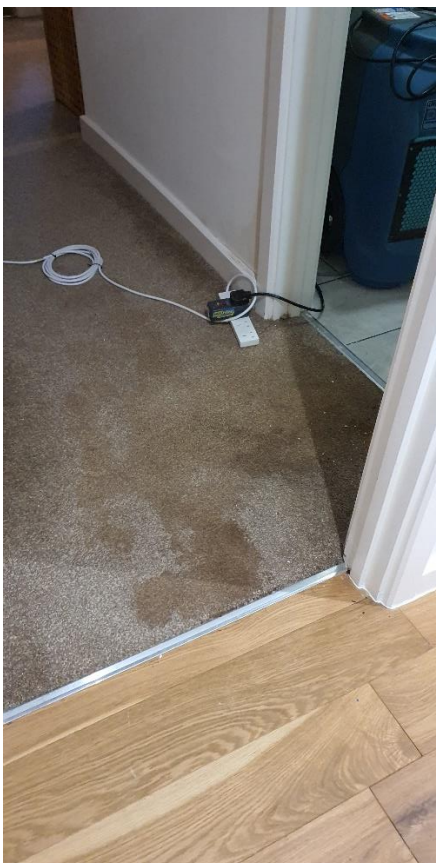
**Bedroom – Stained carpet**

- Carpet and underlay to be removed and disposed of
- Skirting boards to be removed from the affected walls
- Mould contaminated plasterboard to be removed from the affected walls (see attached floorplan with locations) up to 500mm
- A section of chipboard in the entrance to the office to be removed to expose sub-floor void
- Sub-floor void to be inspected and sanitised using a broad-spectrum biocide
- All exposed building materials to be cleaned and sanitised using anti-microbial or broad-spectrum biocide depending on the level of contamination

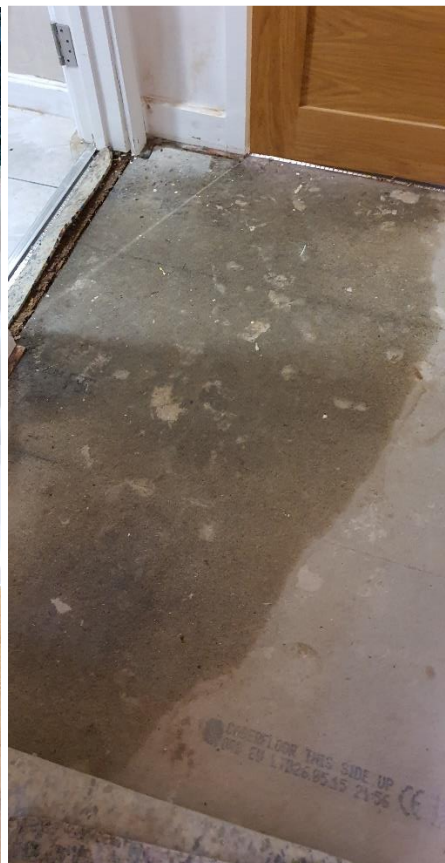
**Bedroom – Visibly wet chipboard floor.**

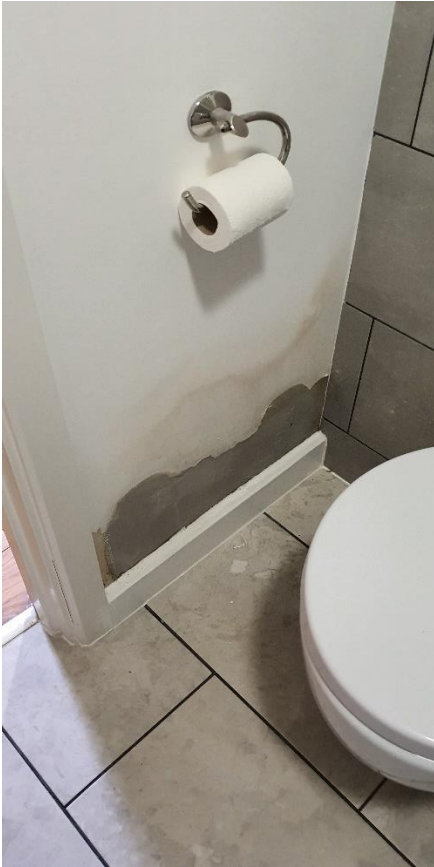
**Bathroom – Damage to the lower wall.**

- Sanitary units to be removed and stored on-site for re-use
- Tiles to be stripped from the affected walls and floor
- Chipboard floor to be removed if necessary
- Sub-floor void to be inspected and sanitised using a broad-spectrum biocide
- All exposed building materials to be cleaned and sanitised using anti-microbial or broad-spectrum biocide depending on the level of contamination

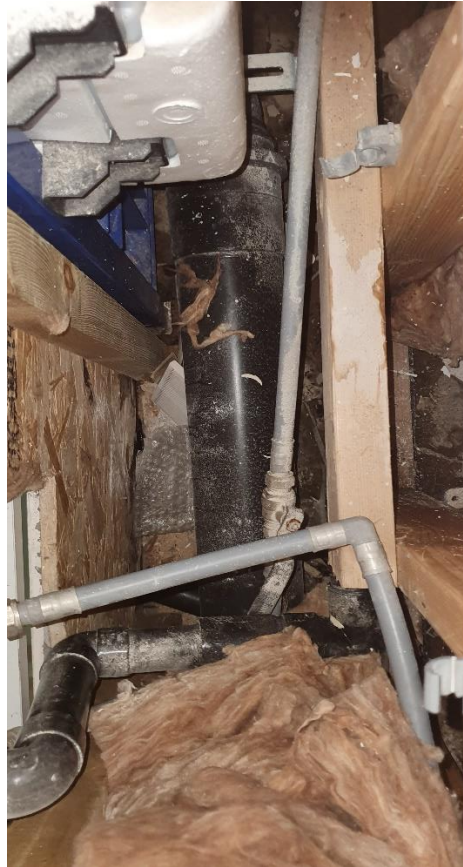
**Bathroom – Boxing behind the toilet visibly wet floor and joinery.**

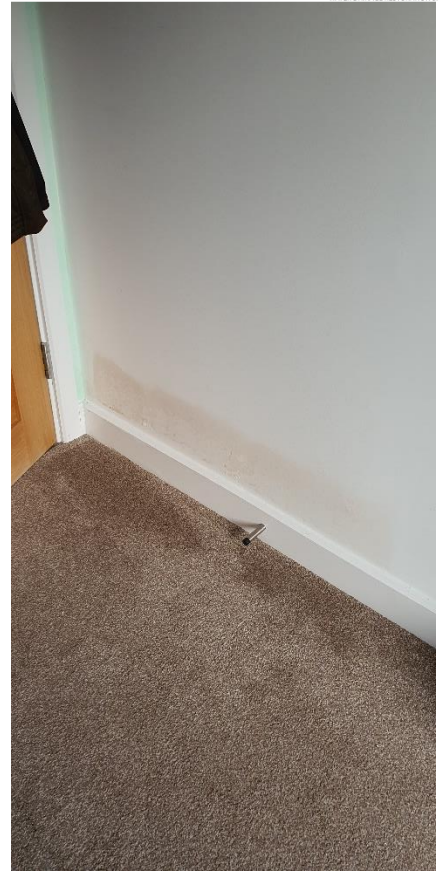
**Office – Damage to the lower wall.**

- Carpet and underlay to be removed and disposed of
- Skirting boards to be removed from the affected walls

- Mould contaminated plasterboard to be removed from the affected walls (see attached floorplan with locations) up to 500mm
- A section of chipboard in the entrance to the office to be removed to expose sub-floor void
- Sub-floor void to be inspected and sanitised using a broad-spectrum biocide
- All exposed building materials to be cleaned and sanitised using anti-microbial or broad-spectrum biocide depending on the level of contamination

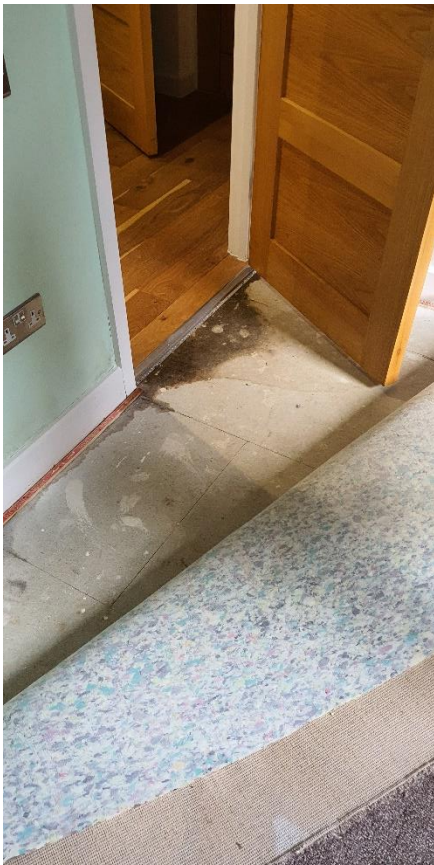
**Office – Damage to the floor.**

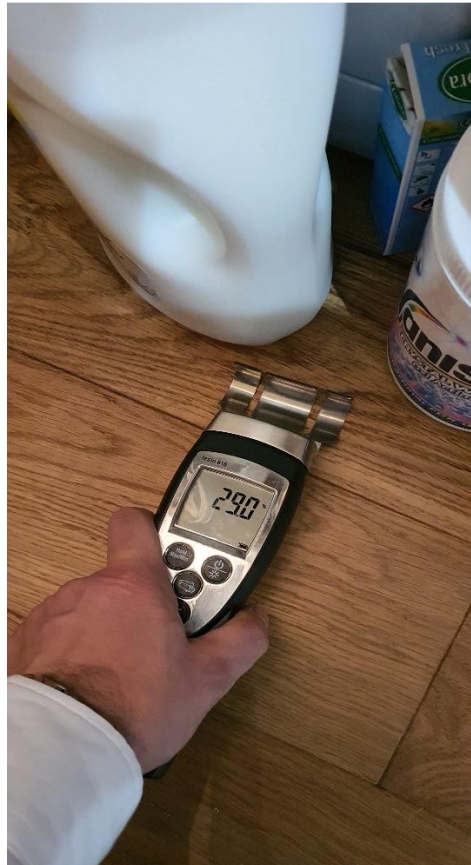
**Hallway Cupboard – Very high moisture levels recorded.**

- Mould contaminated plasterboard to be removed from the affected walls.
- Skirting boards to be removed
- Engineered flooring to be uplifted and disposed of
- Chipboard floor to be inspected and removed if necessary
- Sub-floor void to be inspected and sanitised using a broad-spectrum biocide
- All exposed building materials to be cleaned and sanitised using anti-microbial or broad-spectrum biocide depending on the level of contamination

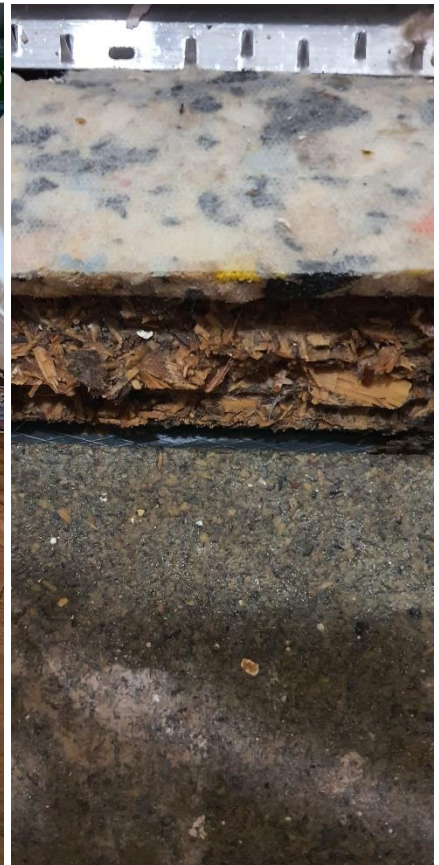
**En Suite – Saturated chipboard floor.**

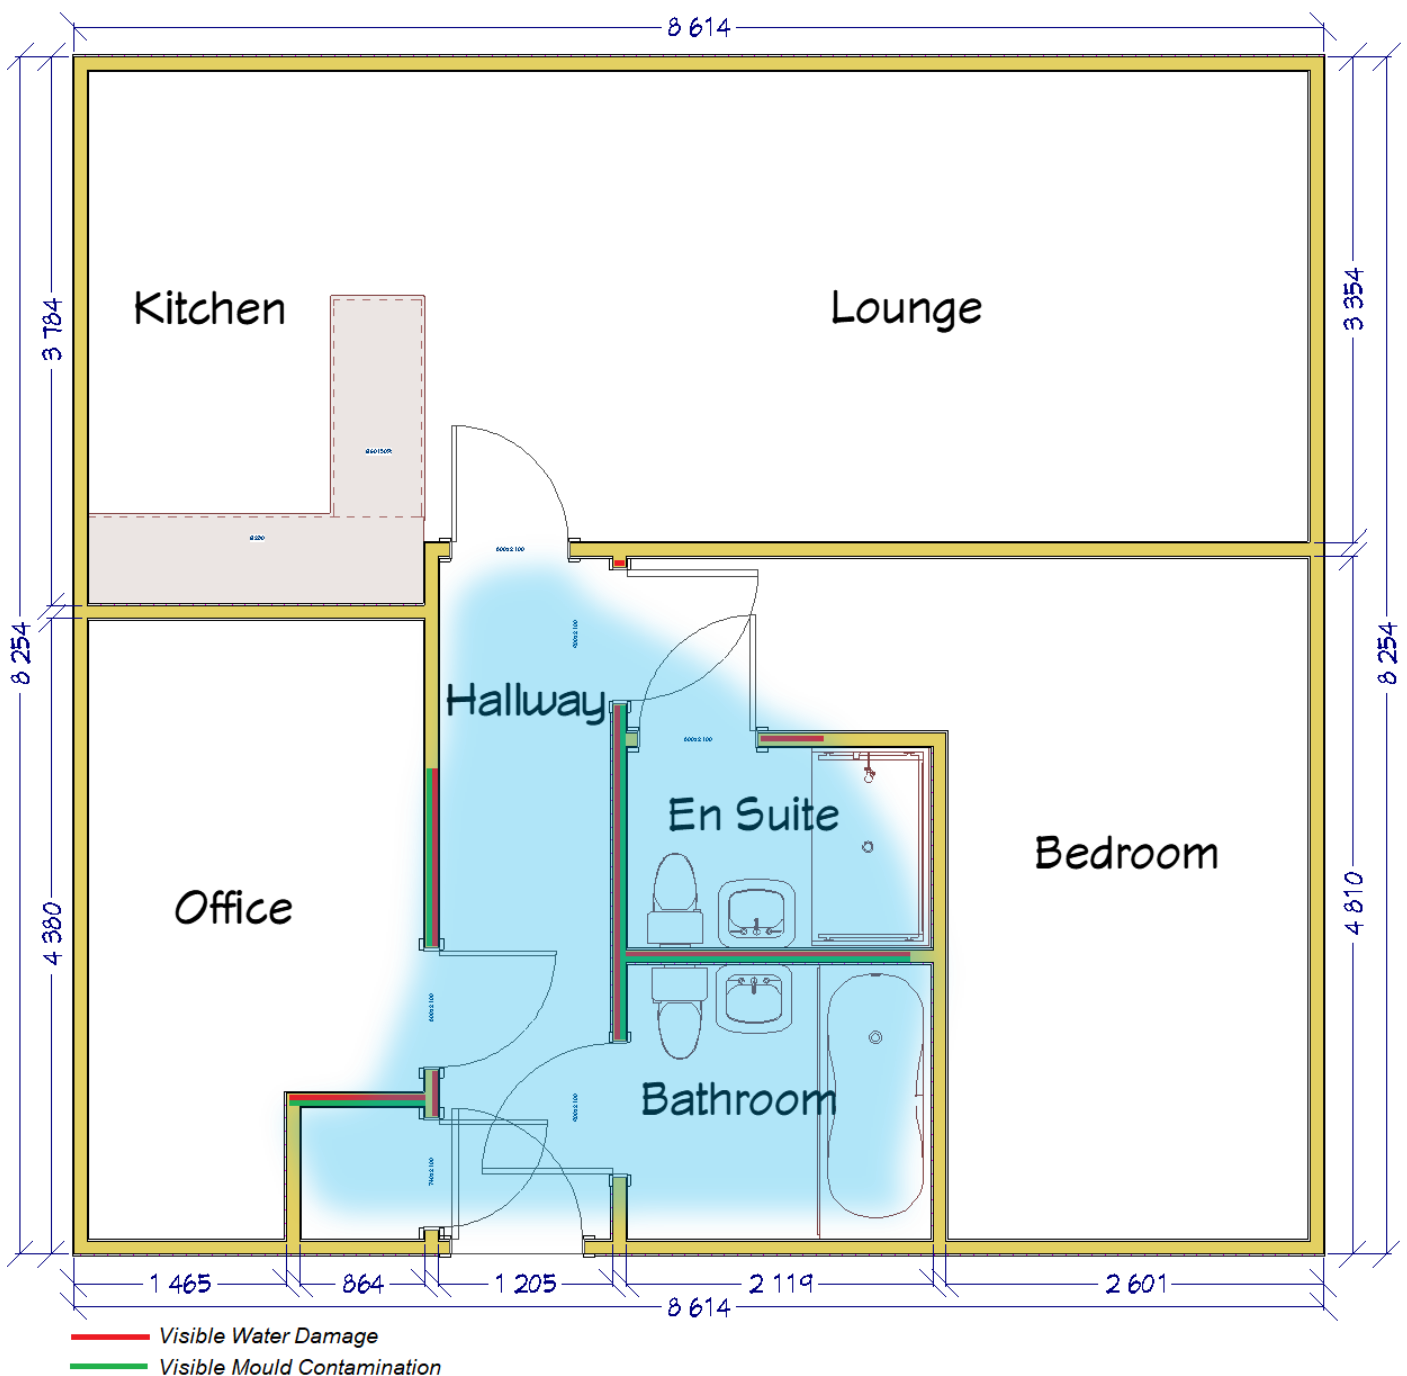
We have carried out a non-invasive moisture survey to confirm the spread of the moisture. We have marked the approximate spread on the floor plan below.

Room	Location / Material	Reading	Notes
Bathroom	Walls / Plasterboard	100% WME	Highest reading which have been recorded in the affected areas.
	Floor / Tiles	999 REL	
En Suite	Ceiling / Plasterboard	100% WME	
	Walls / Plasterboard	100% WME	
Hallway	Floor / Tiles	999 REL	
	Ceiling / Plasterboard	100% WME	
Hallway Cupboard	Walls / Plasterboard	100% WME	
	Floor / Timber	100% WMC	
Bedroom	Walls / Plasterboard	100% WME	
	Floor / Chipboard	100% WMC	
Office	Walls / Plasterboard	100% WME	
	Floor / Chipboard	100% WMC
