FLOOD|DOCTOR
WATER DAMAGE RESTORATION SPECIALIST

TECHNICAL REPORT

The purpose of this visit was to evaluate the moisture levels and carry out a damp and mould survey to the property.

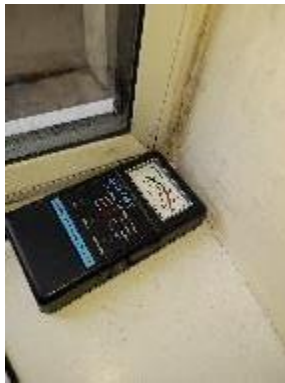
Elevated moisture reading to window board to window in bedroom.

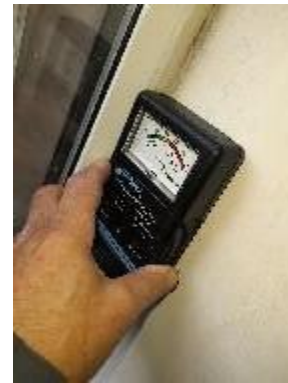
Elevated moisture reading to wall return to window in bedroom

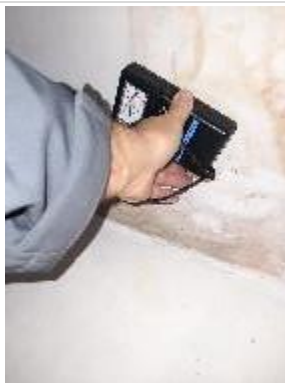
- Visible water damage to part of ceiling, coving and wall covering an area of approximately half square metre. Elevated moisture readings of up to 30% wood moisture equivalent (wme) to the ceiling and upper wall. I understand that water has dripped intermittently from the hole in the ceiling.
- Visible mould growth seen to window board. A small area of the window board had elevated moisture readings of up to 30% moisture content.
- Just above the window board, visible mould growth seen to the wall return to the window. Elevated moisture reading of 25% wme found to this wall.
- Elevated moisture readings found to lower part of wall and skirting beneath the water damaged ceiling. The elevated moisture readings were 30% wme to the wall and 30% mc to the skirting.
- The sub floor to this room is concrete/screed covered with floor laminate.

Water damage to bedroom ceiling.

- The water damage to the ceiling, coving and wall is being caused either by ingress of water from the flat above due to a leak from the en-suite or bathroom. I entered the flat above and at the time of my visit was unable to locate a leak, although there was some visible water damage to the wall by the shower to in the en-suite. The other potential cause of water damage could be due to rainwater ingress through the hole in the external wall above the bedroom.
- Flood Doctor would recommend that the owner of the flat above is asked to run the shower to see if any water enters the bedroom. If no water enters the flat, then the bathroom appliances need to be run to check if any water enters the bedroom. If no water enters the bathroom, then the cause of water damage could be rainwater entering the property through hole in the external wall.

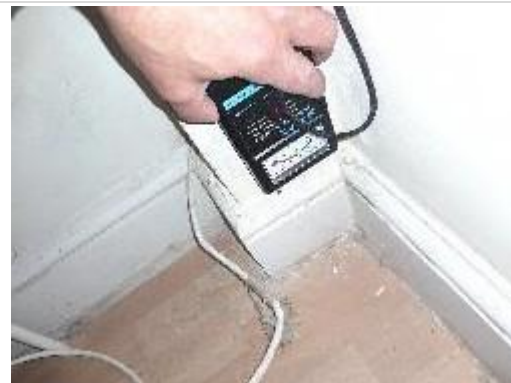
Elevated moisture reading to lower wall in bedroom.

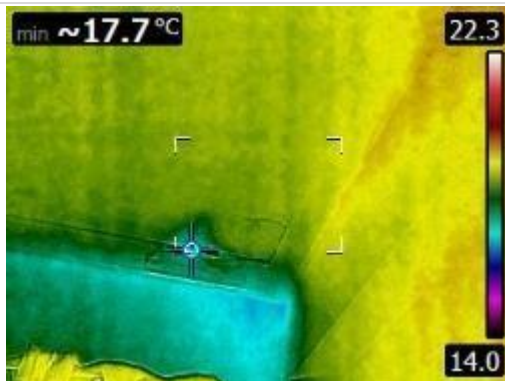
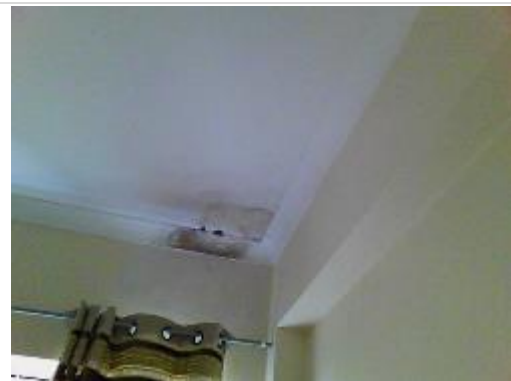
Thermal image of water damaged area of bedroom ceiling, coving and upper wall.

Photo of water damaged area of bedroom ceiling, coving and upper wall.

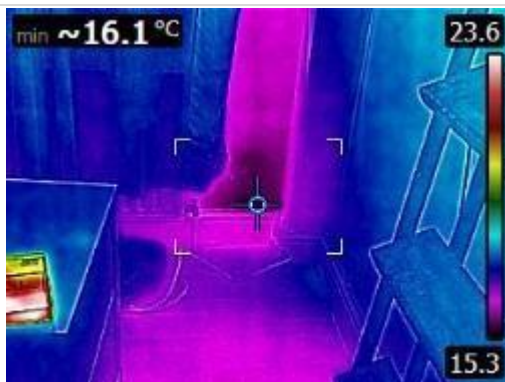
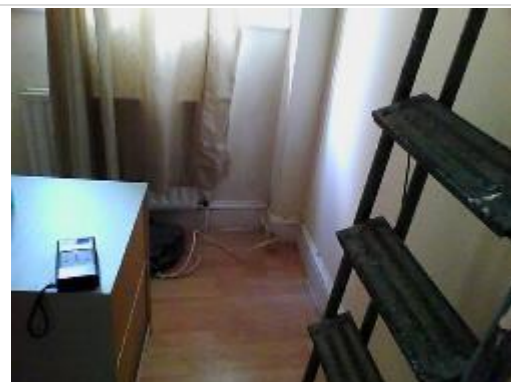
Thermal image of lower part of bedroom wall where elevated moisture readings located.

Photo of lower part of bedroom wall where elevated moisture readings located.

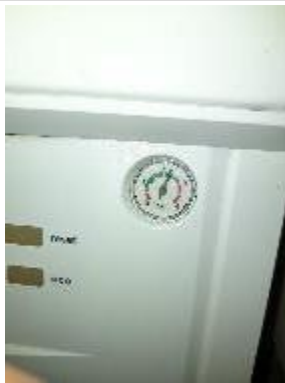
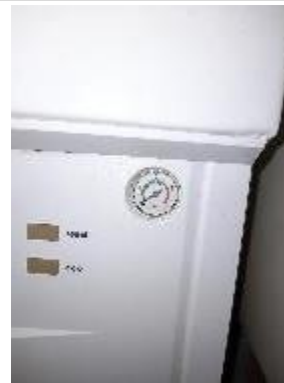
- The extension comprises of a kitchen and bathroom.
- There were no signs of water damage to this area at the time of my visit.
- I checked the combi-boiler and found that the pressure gauge was at zero. I put water into the boiler and took a photo of the gauge which showed the dial at just above 2 bars.
- There are no extractor fans in the kitchen or bathroom.

Boiler gauge showing just above 2 bars after being filled.

Boiler gauge showing empty after approximately half hour being filled.

- The water pressure to the boiler has dropped to zero which indicates either there is a leak from the pipes or there is a problem with the boiler. Further investigation is required to confirm what the problem is as if a pipe is leaking it is possible that the leak is causing water damage to the property and could be part of the reason for high Relative Humidity in the flat and part of the reason for mould growth.
- As there are no extractor fans fitted it is possible that this is another reason for mould growth within the property. It would be good practice to fit extractor fans, which incorporate humidistats.

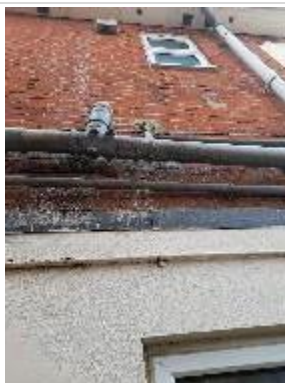
- There is a hole in the brick wall, where a pipe protrudes out, just above the area of water damage to the bedroom ceiling.
- To the front corner of the property there is gutter dripping water onto the pavement just in front of this flat.
- Parts of the air bricks, to the suspended wood floor, are partially blocked.

Hole in brick wall where pipe protrudes out.

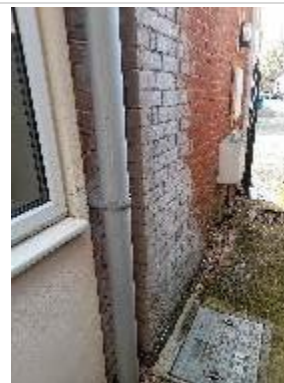
- The external dpc, where visible on the side elevation, is not 150 mm above the external ground. A French gully has been put in place, running along side the brick wall, but this is not 150 mm below the dpc. The French gully does not run off into a drain.
- There was and possibly still is an escape of water from an overflow pipe from above this property as there is large visible water stain on the brick wall.

Water staining to external wall to the outside of the bedroom.

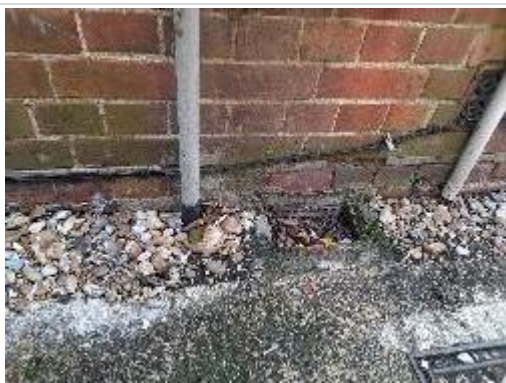
Visible slate dpc just above French gully. Airbrick partially blocked by gravel/debris

- The air bricks need to be cleared of blockages. Air bricks being blocked will prevent air flow to the void and evaporation from the void. The suspended wood floor could then have mould growth and wood decay (wet or dry rot) to the wood floor joists and floorboards.
- The external ground needs to be 150 mm beneath the dpc. It would be good practice to lower the external ground level.

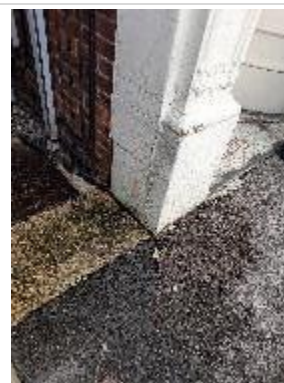
Dripping water from gutter to front corner of the flat.

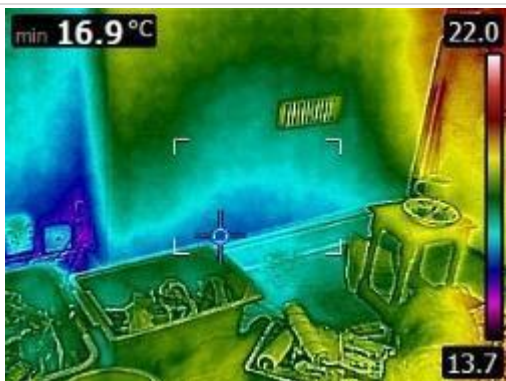
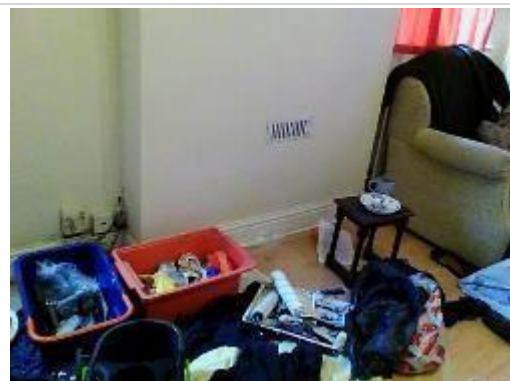
Thermal image of fireplace in lounge/diner showing areas of elevated moisture readings. Blue is area of elevated readings.

Photo of fireplace in lounge/diner showing areas of elevated moisture readings

- The elevated moisture readings to the lower parts of the walls may be due to previous ingress of water due to the dpc being breached or fossil fuel residue around the fireplace.
