FLOOD DOCTOR
WATER DAMAGE RESTORATION SPECIALIST

TECHNICAL REPORT

The purpose of this visit was to carry out a thorough inspection of the property to establish the cause behind outbreaks of abnormal microbial growth in multiple rooms and put forward a remediation proposal and recommendations to prevent further outbreaks.

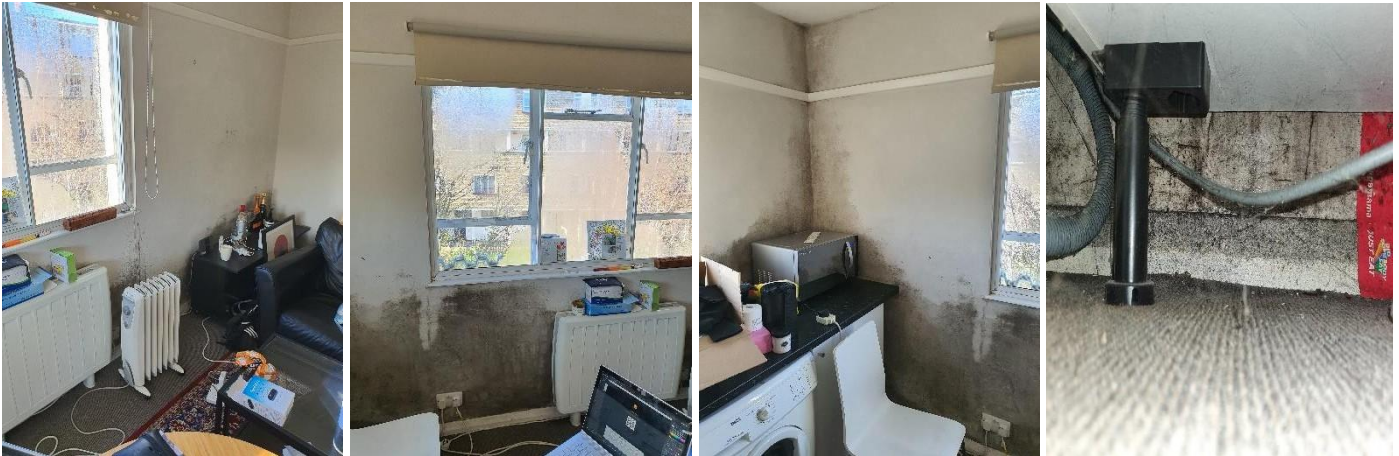
Kitchen/Lounge - Photos

As you can see from the above photos, the open plan kitchen lounge is heavily contaminated with mould, including behind the kitchen units.

In our opinion, the primary reason behind the outbreak of abnormal microbial growth in the kitchen and bedroom is the leak from the kitchen sink. Based on the level of corrosion to the underside of the sink and damage to the underside of the worktop as well as the back of the cupboard, the leak must have been on-going for some time.

- Kitchen units to be removed to facilitate cleaning, sanitation and drying of the walls and floor
- Carpet to be rolled back to facilitate cleaning, sanitation and drying.
- Elec. Radiator to be removed to facilitate cleaning and sanitation of the wall behind
- Skirting boards to be removed from water-damaged walls to facilitate drying
- All exposed surfaces to be cleaned using HEPA vacuum, followed by a chemical wash using a broad-spectrum biocide
- Installation of drying equipment to remove excess moisture from the affected areas

Please note that due to the level of water damage it is unlikely that the worktop and some of the kitchen units will be salvageable.

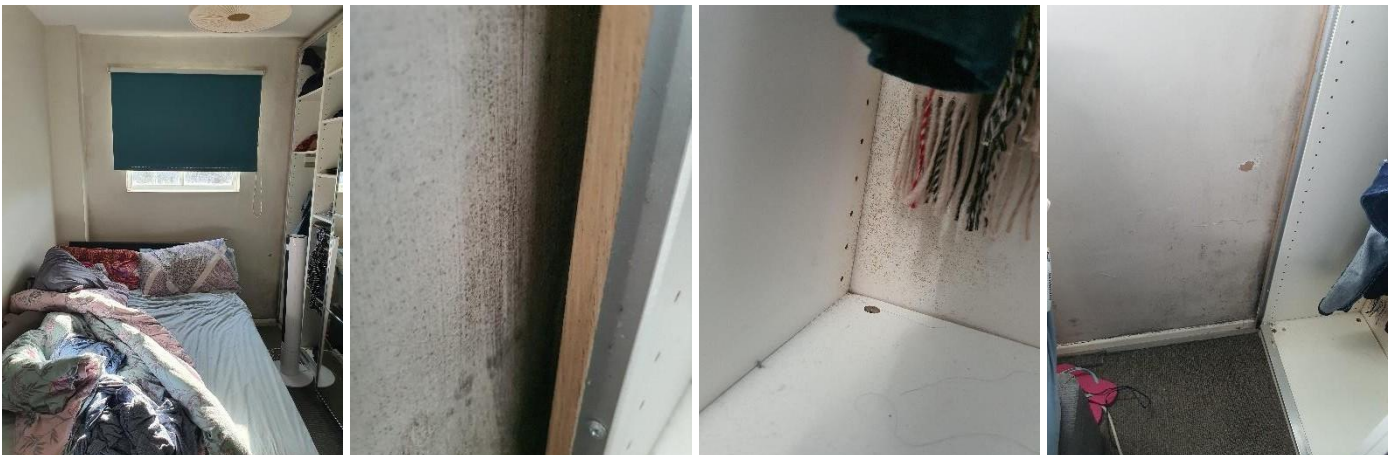
Bedroom

Visible mould contamination to the entire external wall, most of the contamination appears to be located behind the wardrobe which is situated along the partition wall dividing bedroom and kitchen. Back of the wardrobe is also showing signs of mould contamination.

Similarly, as in the bathroom at the time of our visit, the only area which showed as at risk of condensation was a lower wall behind the wardrobe. In our opinion, there are several factors behind the outbreak in this area:

1. A leak in the adjacent kitchen due to faulty seal around the sink. More information about this in the Moisture Survey section of this report.
2. The wardrobe is restricting air circulation in this area; this leads to a build-up of condensation on the wall, which contributed to some extent to the outbreak of mould growth in this room.
3. A single glazed window which is prone to condensation
4. Roller blind which is restricting airflow through the window vent

- Cleaning and sanitation of the affected surfaces
- Removal of skirting boards from the affected walls
- Installation of targeted drying regime to remove excess moisture from the affected walls and floor

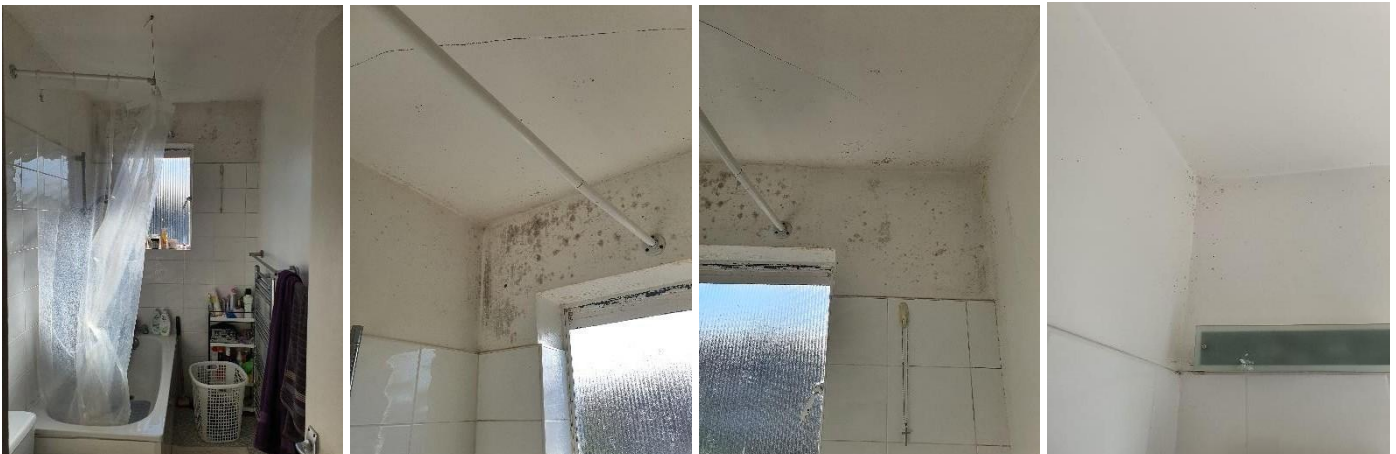
Bathroom

Visible mould contamination mainly around the window although partition wall dividing bathroom and hallway has also been affected to a lesser extent.

In our opinion, the outbreak of abnormal microbial growth in the bathroom is not related to the issues affecting the kitchen and bedroom. The bathroom has no extractor fan or a vent and only a single glazed window. This would lead to a build-up of condensation and humidity levels in this room, which resulted in the outbreak of mould growth over time.

- Cleaning and sanitation of the affected surfaces

- Replacing existing windows with double glazed windows with trickle vents
- Installation of an extractor fan in the bathroom
- Replacing faulty kitchen hood

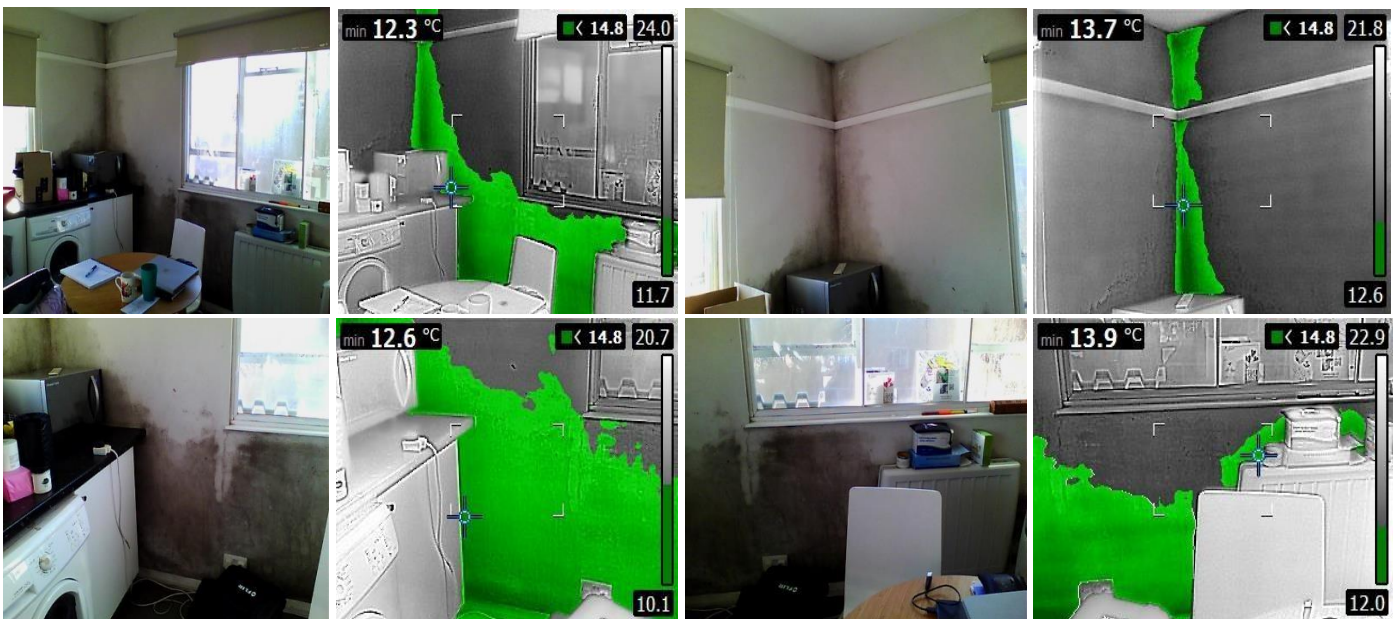
Kitchen / Lounge

A “wet” building materials will be cooler than surrounding “dry” building materials. Therefore wet building materials may be more prone to condensation due to lower temperature. In this case, we have found that a large section of the external wall appears to be at risk of condensation however upon closer inspection we have noted that the walls, skirting boards and the floor along the affected walls are wet.

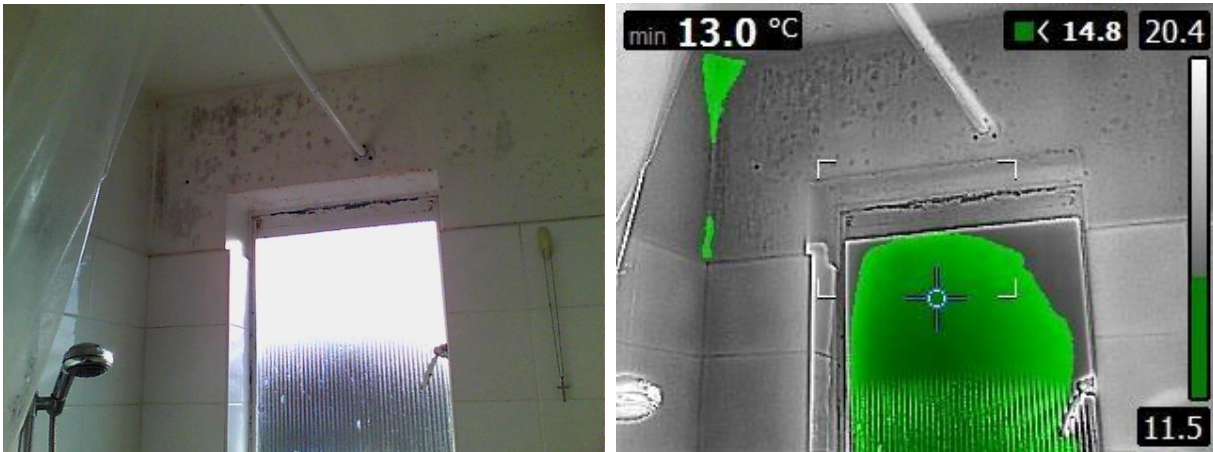
Bathroom

At the time of our visit, the only areas prone to condensation in the bathroom were a window and a small section of the wall in the corner. This indicates that the outbreak of mould in this area is most likely due to a single glazed window and lack of extractor fan.

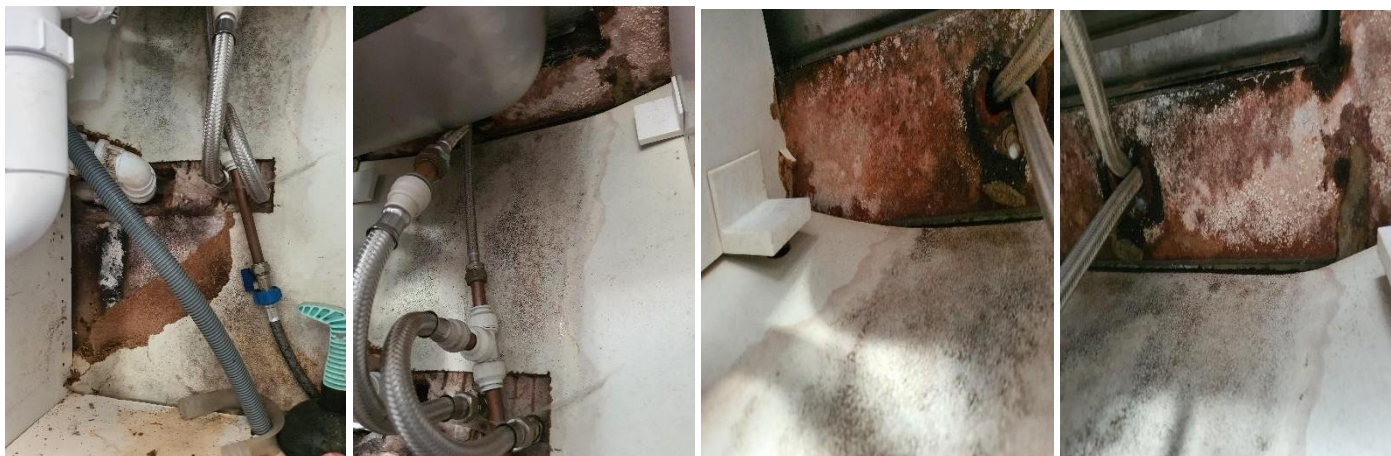
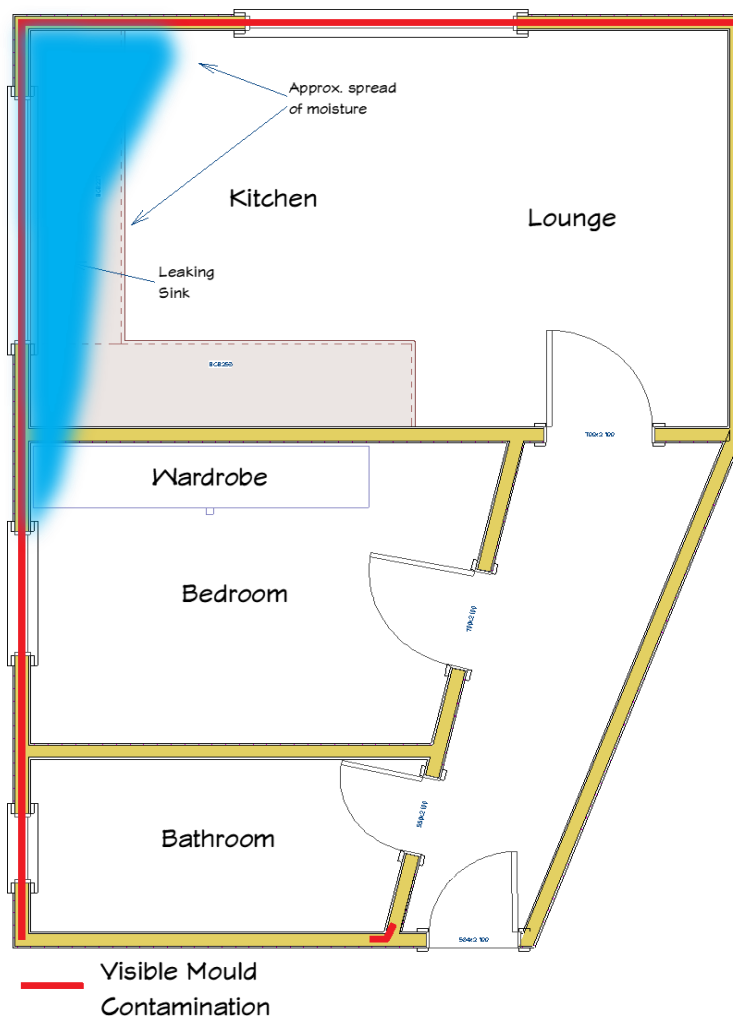
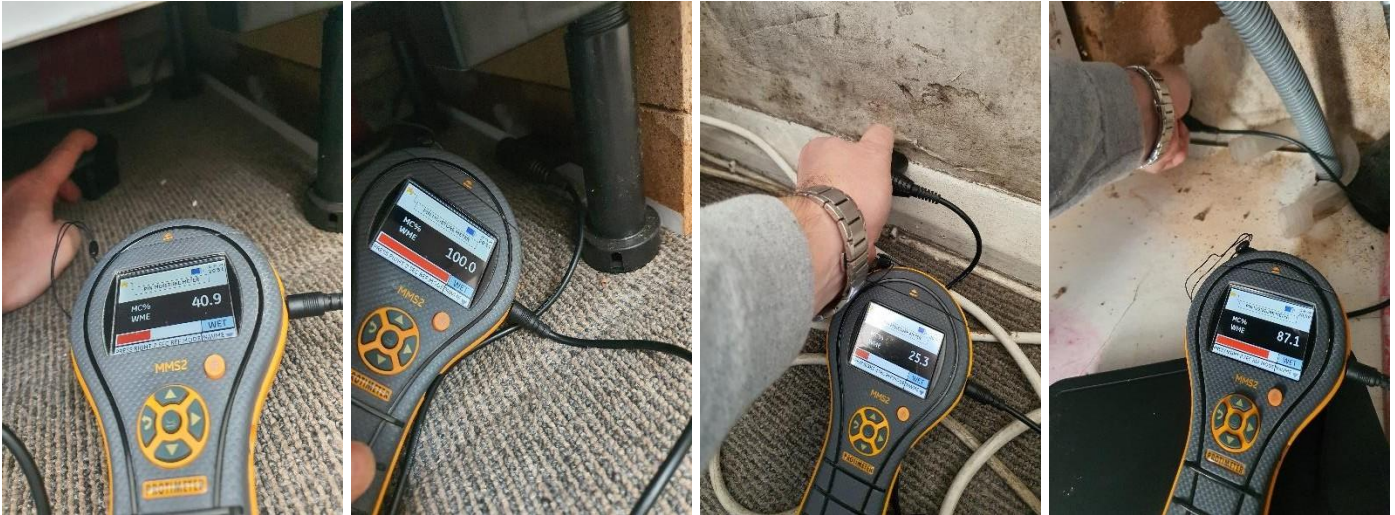
As part of our survey, we have taken a number of moisture readings throughout the property. We have found a leak from the kitchen sink during this part of our investigation.

Please note that the leak is relatively small; however every time the sink is in use a small amount of water is penetrating below the worktop and behind the kitchen units. Furthermore, the leak was impossible to notice without removing all of the contents of the cupboard below the sink.

As you can see from the above photos at the time of our visit, we have recorded elevated to very high moisture readings on the lower external wall, floor, base cupboard side panel (which is water stained), and back of the sink cupboard.
