FLOOD | DOCTOR
WATER DAMAGE RESTORATION SPECIALIST

PRELIMINARY REPORT

The purpose of the inspection was to assess the extent of water damage resulting from an escape-of-water (EOW) incident originating within the kitchen area.

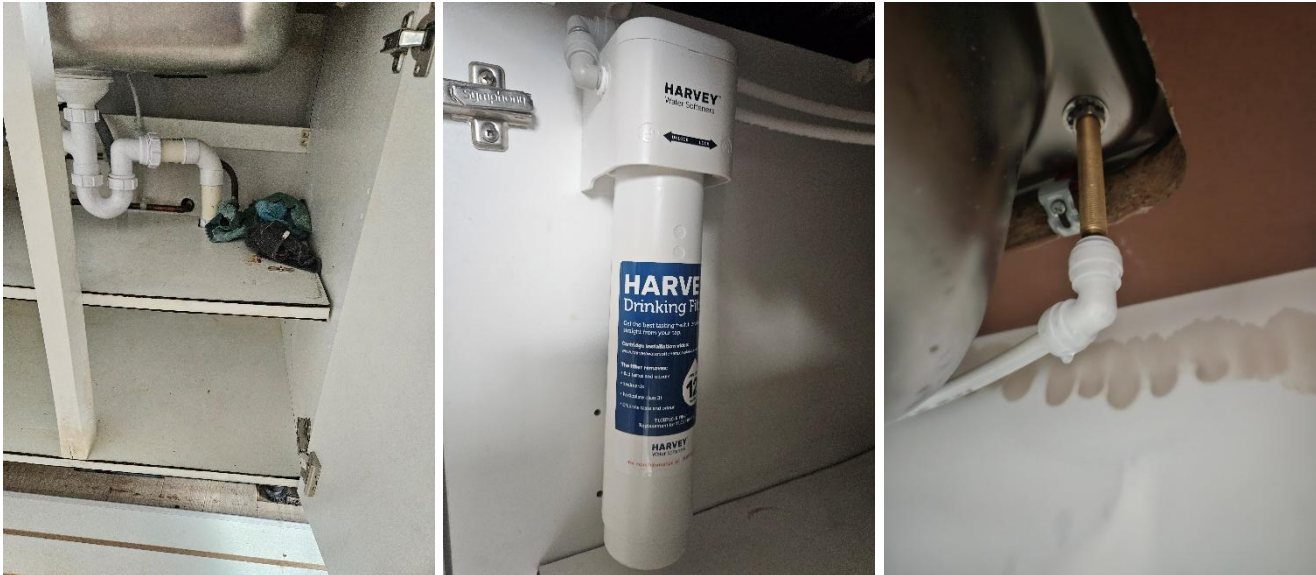
Upon restoration of the water supply, a leak became immediately apparent. Water was observed discharging from a plastic push-fit elbow (L-bend) connector located beneath the kitchen sink. This fitting connects a flexible plastic feed line from the Harvey water softener unit to the metallic threaded tail of a secondary tap (likely a dedicated filtered water tap installed as part of the softener system). The leak was identified at the push-fit joint interface, with active dripping noted within seconds of repressurisation.

The mains water supply was immediately switched off to prevent any further damage. Upon closer inspection we have noted a separate valve within the water supply to the softener which has been switched off. This allowed us to isolate the water supply to the softener but restoring the water supply to the rest of the property.

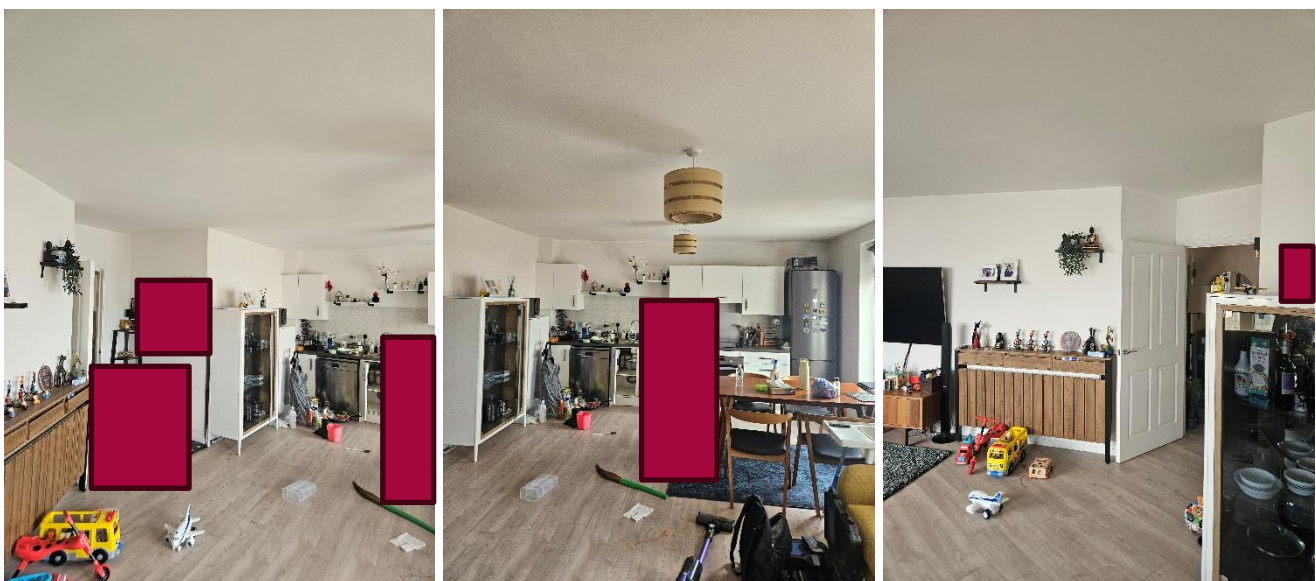
We began visual inspection of this area, during this part of the survey we have noted the following:

- Swelling and bowing of the laminate floor finish
- Staining, expansion, and paint failure to multiple kitchen units, end panels and kickboards.
- Localised deterioration to skirting boards and architraves, including splitting, surface blistering, and loss of integrity to paint finishes.
- Visible water staining and paint discolouration to lower wall surfaces and skirtings.
- Upon removal of the kitchen plinth, early-stage microbial (mould) growth was observed forming on the concealed surfaces of the skirting boards and the lower sections of plasterboard wall behind the kitchen units, indicating the onset of fungal activity due to sustained moisture exposure.

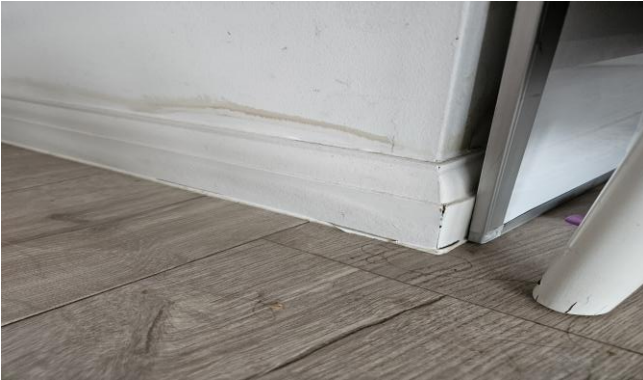
Brown moisture staining to lower wall, swelling of the skirting boards.

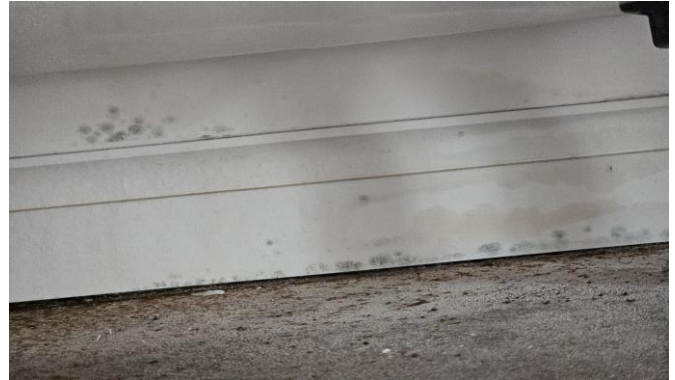
Fungal colonisation along skirting board and lower wall

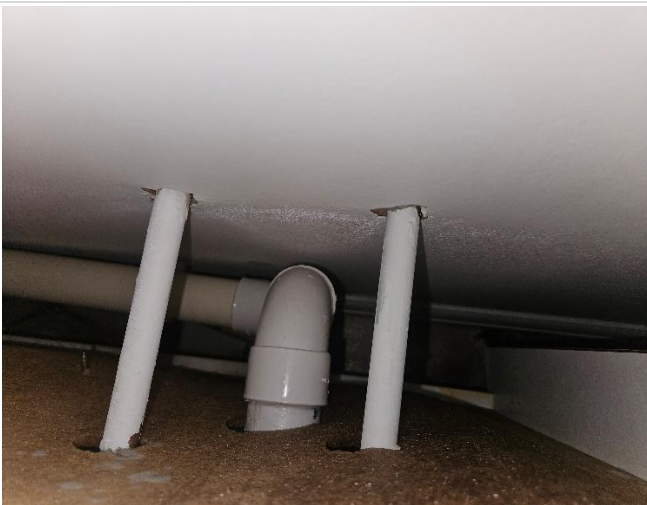
Condensation and mould growth behind kitchen units

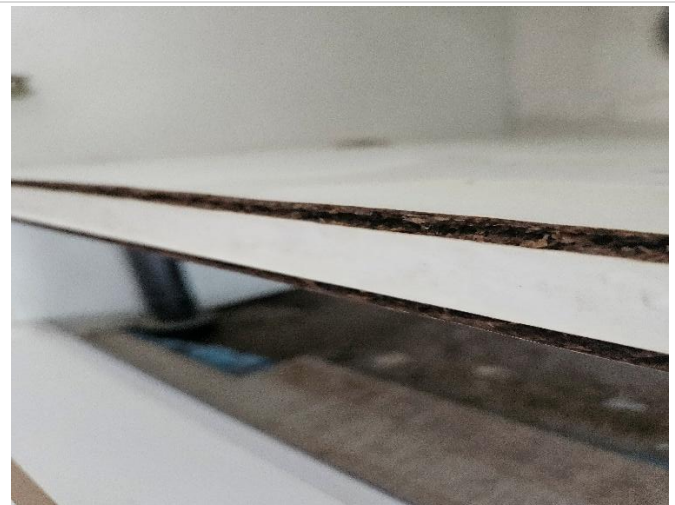
Swollen particleboard shelf with visible edge delamination indicative of prolonged water exposure.

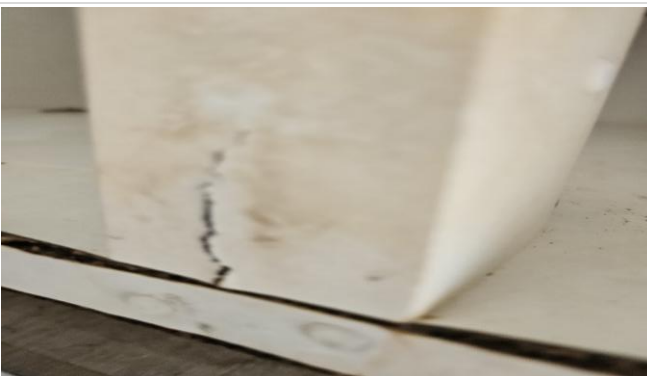
Vertical cracking and edge swelling of internal panel

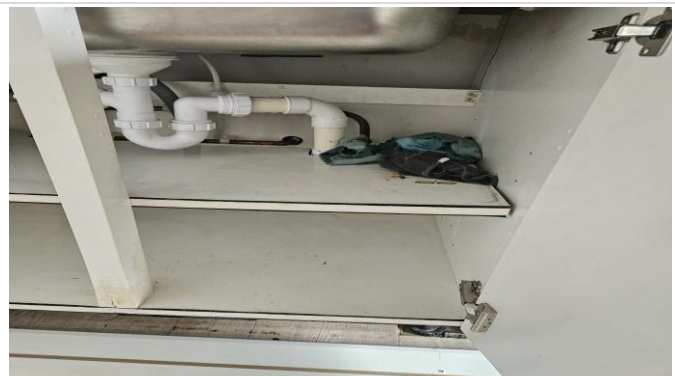
Widespread swelling and staining of the sink cupboard

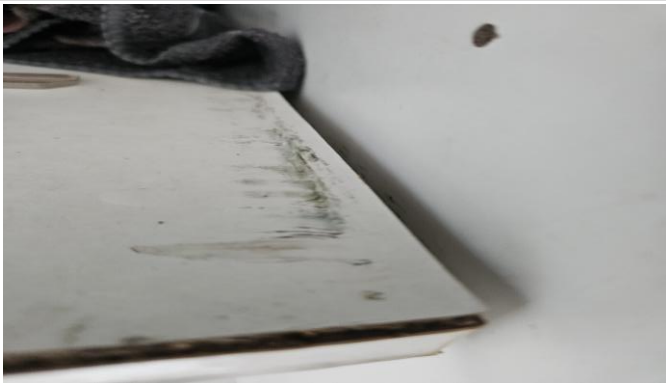
Swelling and mould contamination on the surface of the shelf

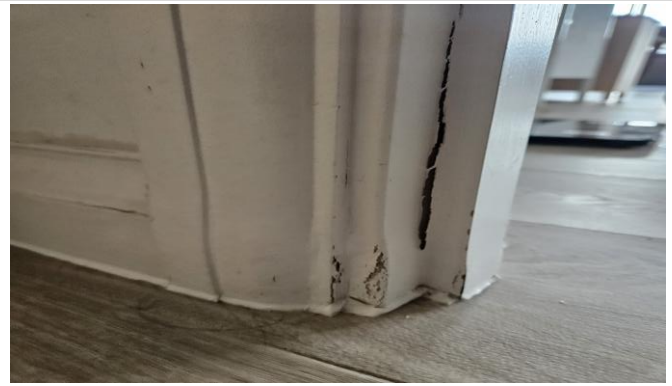
Swelling, splitting of the door frame and architrave, peeling of paint

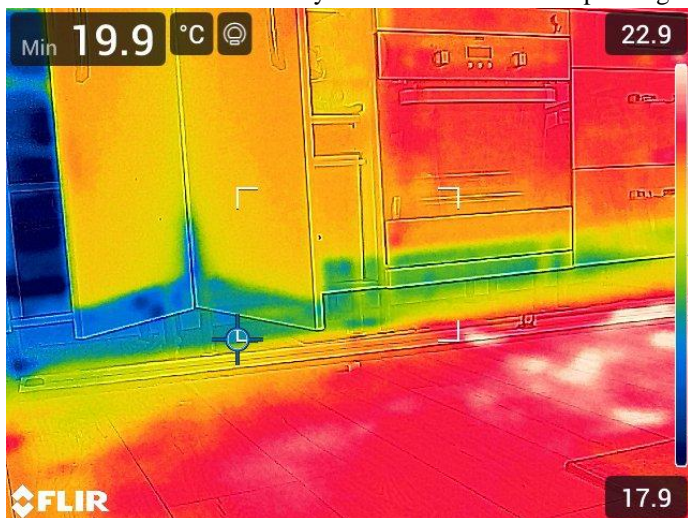
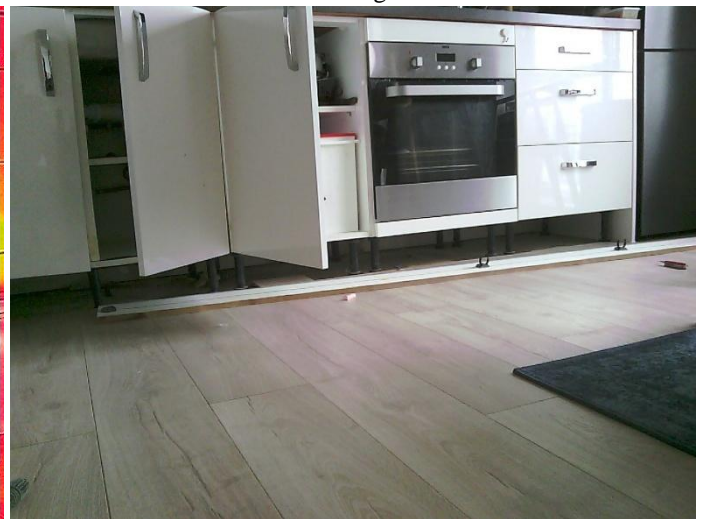
Visible thermal anomaly at the base of the wall spanning whole width of the kitchen indicating moisture accumulation

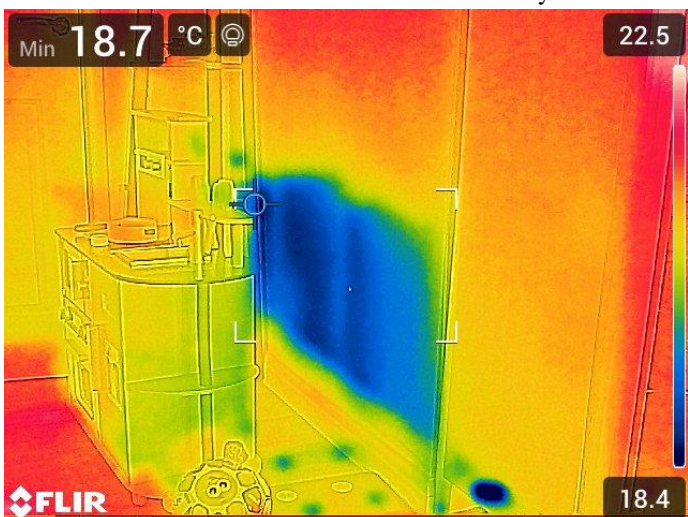
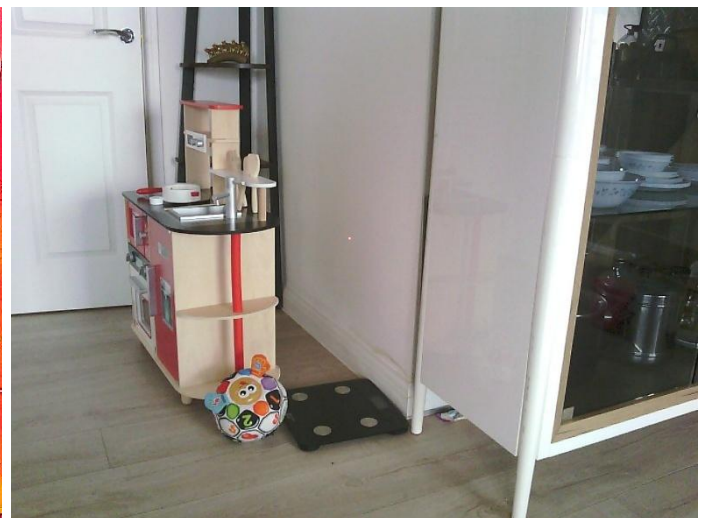
Localised thermal anomaly to lower internal wall indicative of moisture retention

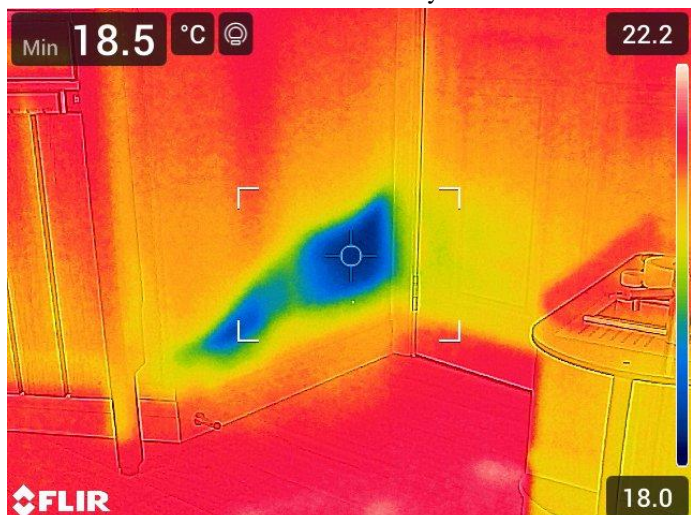
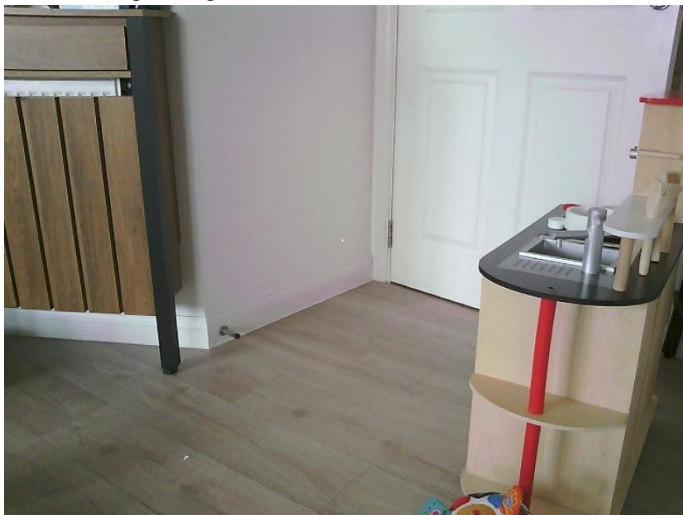
Thermal anomaly noted at the base of the wall dividing dining area and bedroom 1

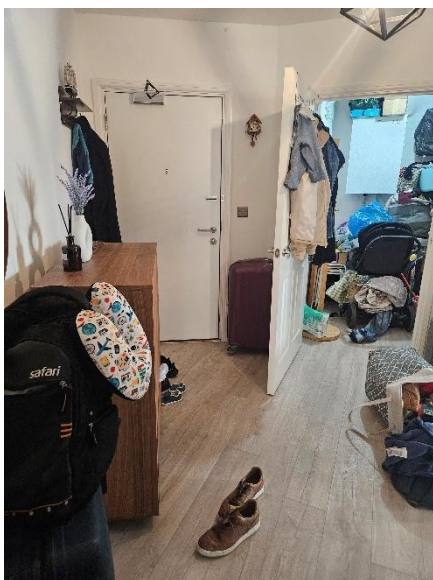
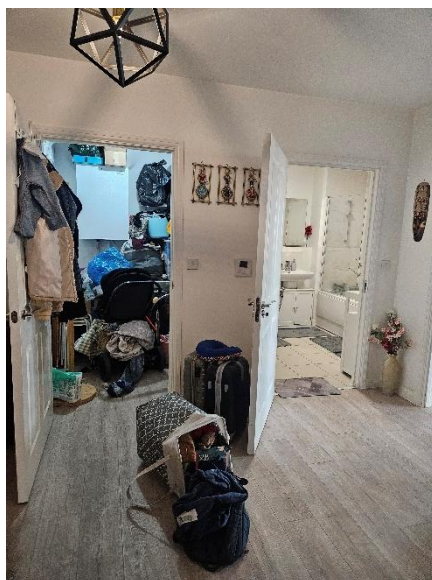
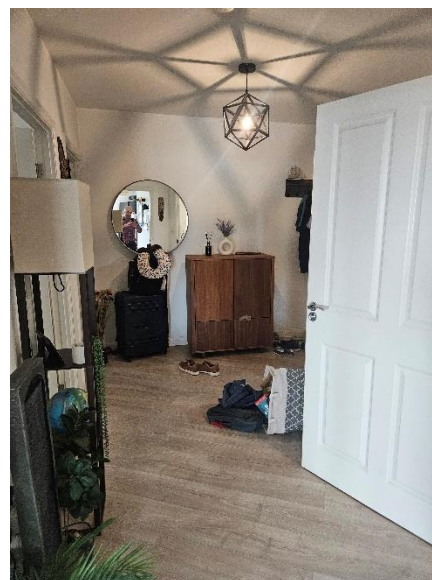
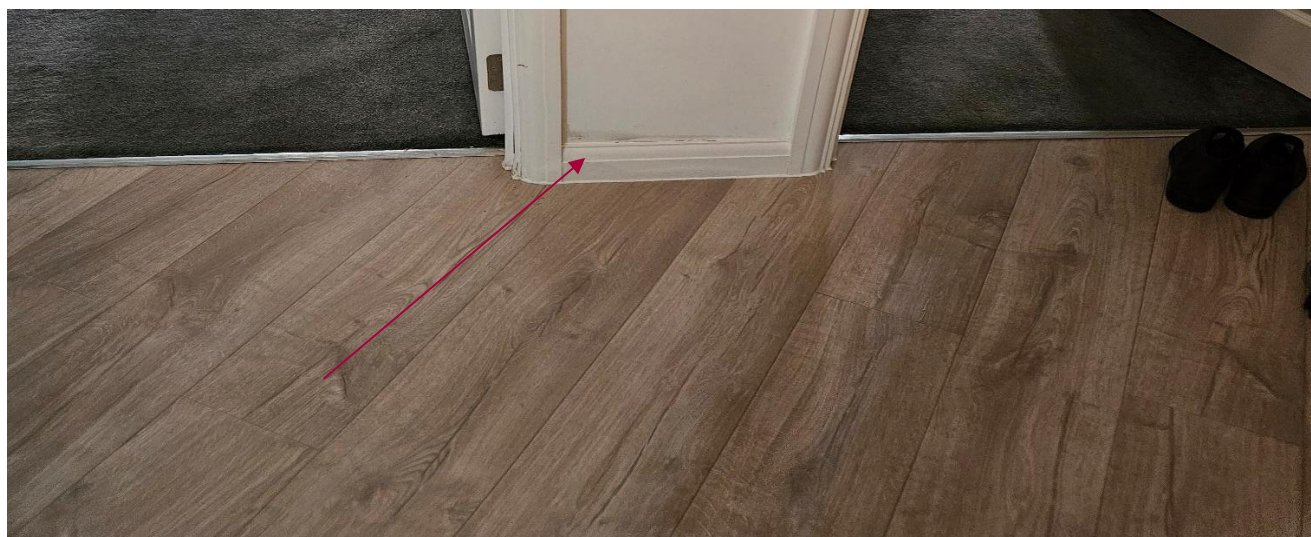
Whilst inspecting this part of the property we have noted staining to the lower wall dividing bedroom 1 and master bedroom as well as swelling of skirting boards indicating that the water/moisture has spread from the kitchen all the way to the front door.

We have also noted that virtually all door frames and architraves in the hallway area sustained water damage at a low level (swelling, cracking & paint peeling).

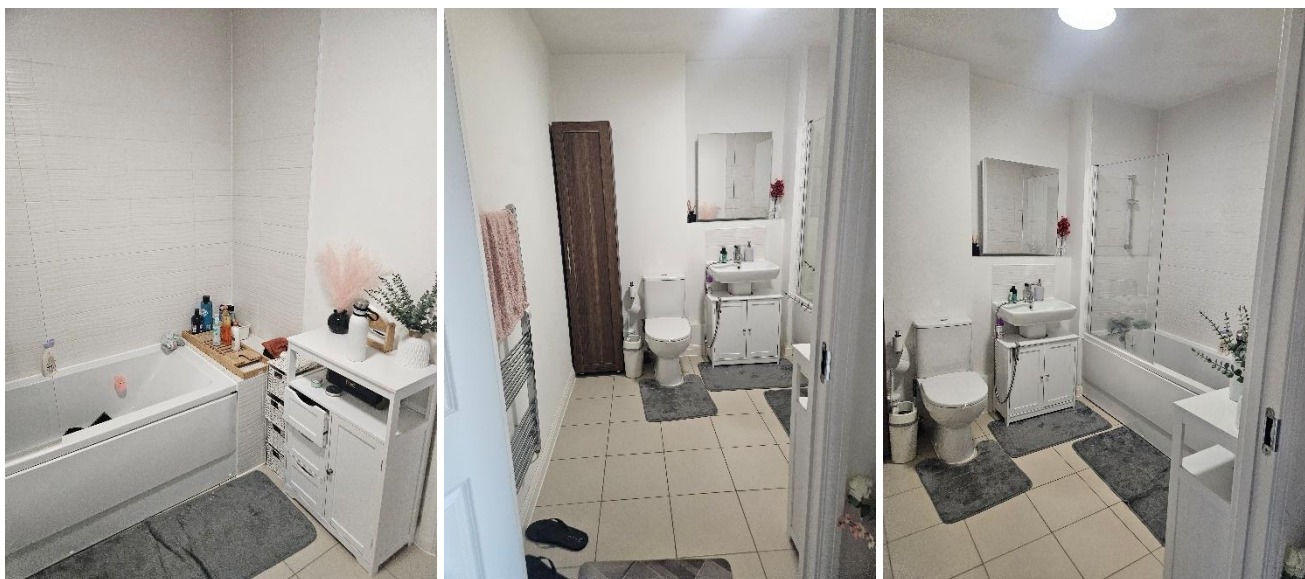
At the first glance bathroom is not showing any major signs of damage except for the visible damage to the lower door frame and architrave, however upon closer inspection we have noted the following additional damage:

- Swelling and delamination of skirting boards from the walls particularly adjacent to the door
- Staining on the lower walls on the wall dividing the bathroom and the hallway

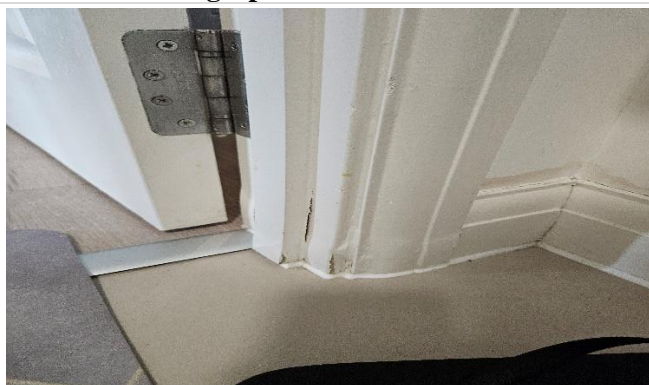
Swelling and cracking of the door frame and architrave

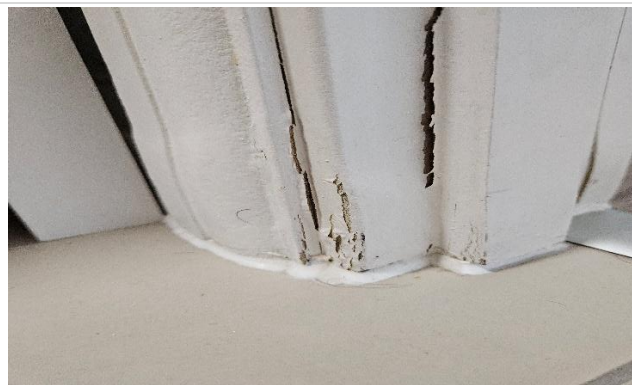
Swelling and cracking of the door frame and architrave

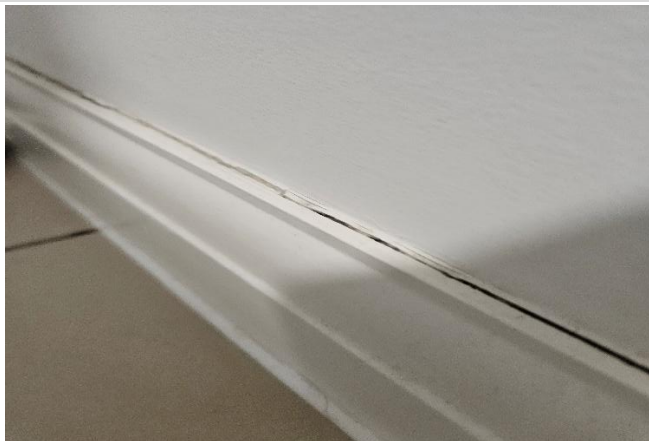
Debonding of the skirting board from the wall behind

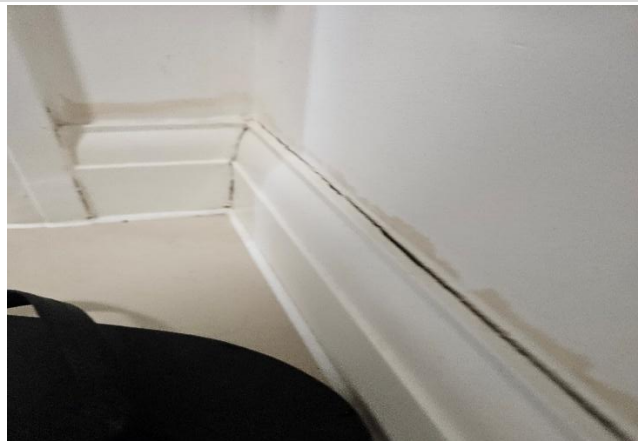
Swelling & debonding of the skirting board, staining of the lower wall`

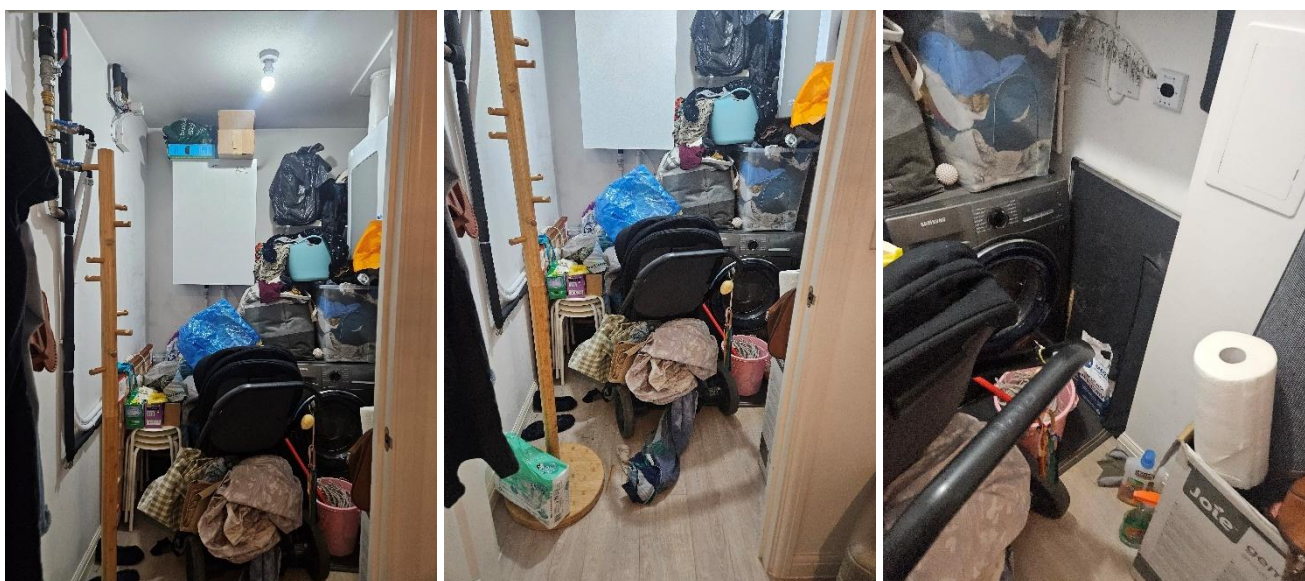
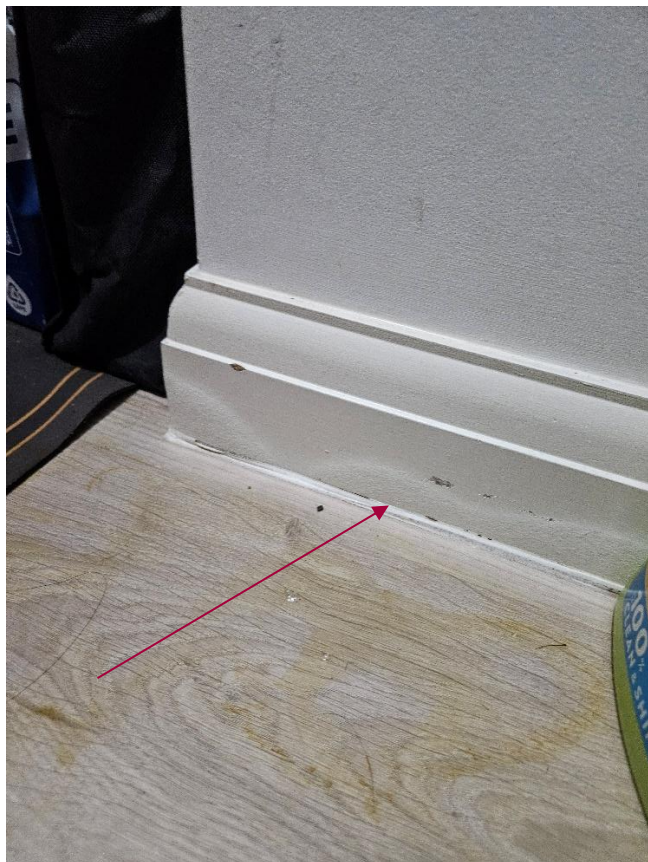
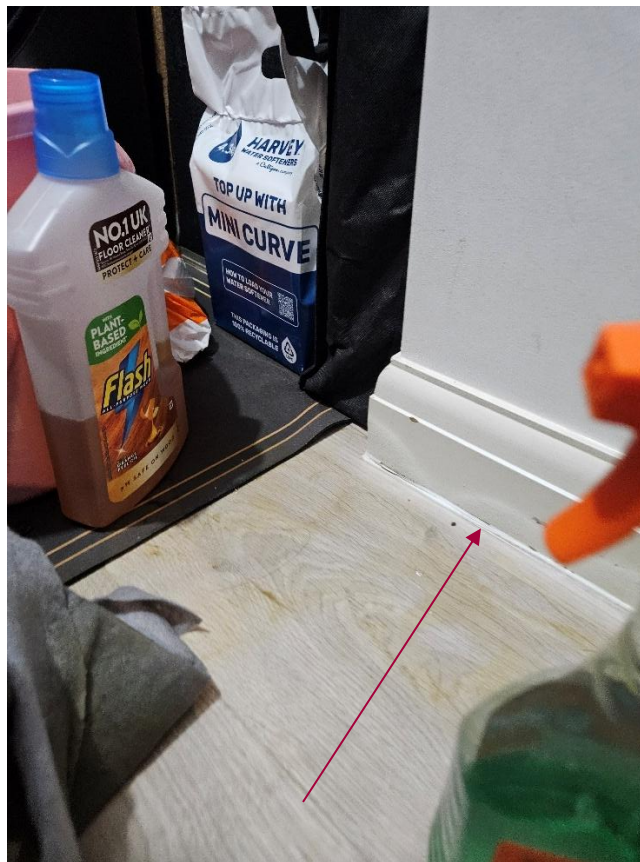
Access to parts of the cupboard area was restricted due to the presence of contents; however, standing water & water staining was observed on sections of the cupboard floor. Additionally, localised swelling of the skirting board was noted, indicating that moisture has migrated into this area resulting in material saturation.

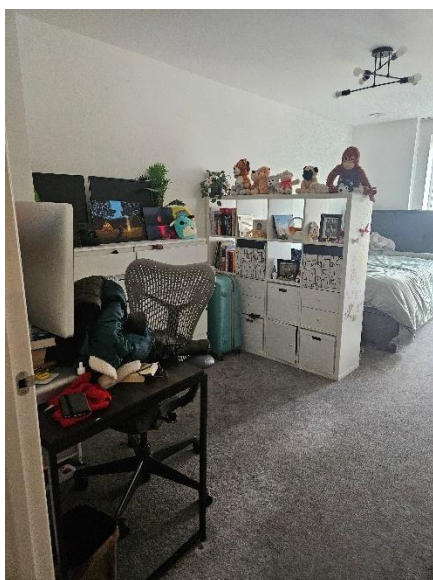
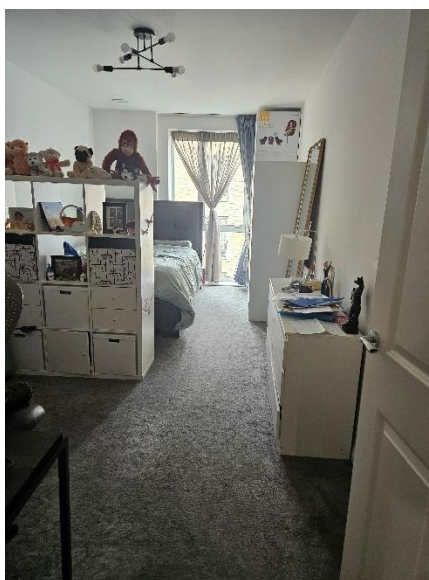
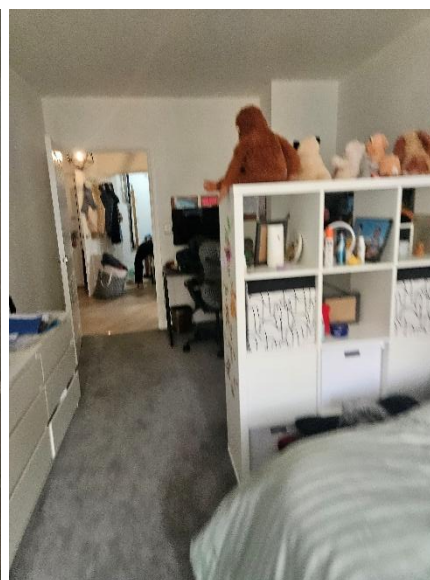
- Localised swelling and fracturing of the door frame and associated architrave elements.
- Moisture-induced distortion and expansion of skirting boards.
- Approximately 20% of the carpeted area was found to be heavily saturated, exhibiting signs of prolonged water exposure.

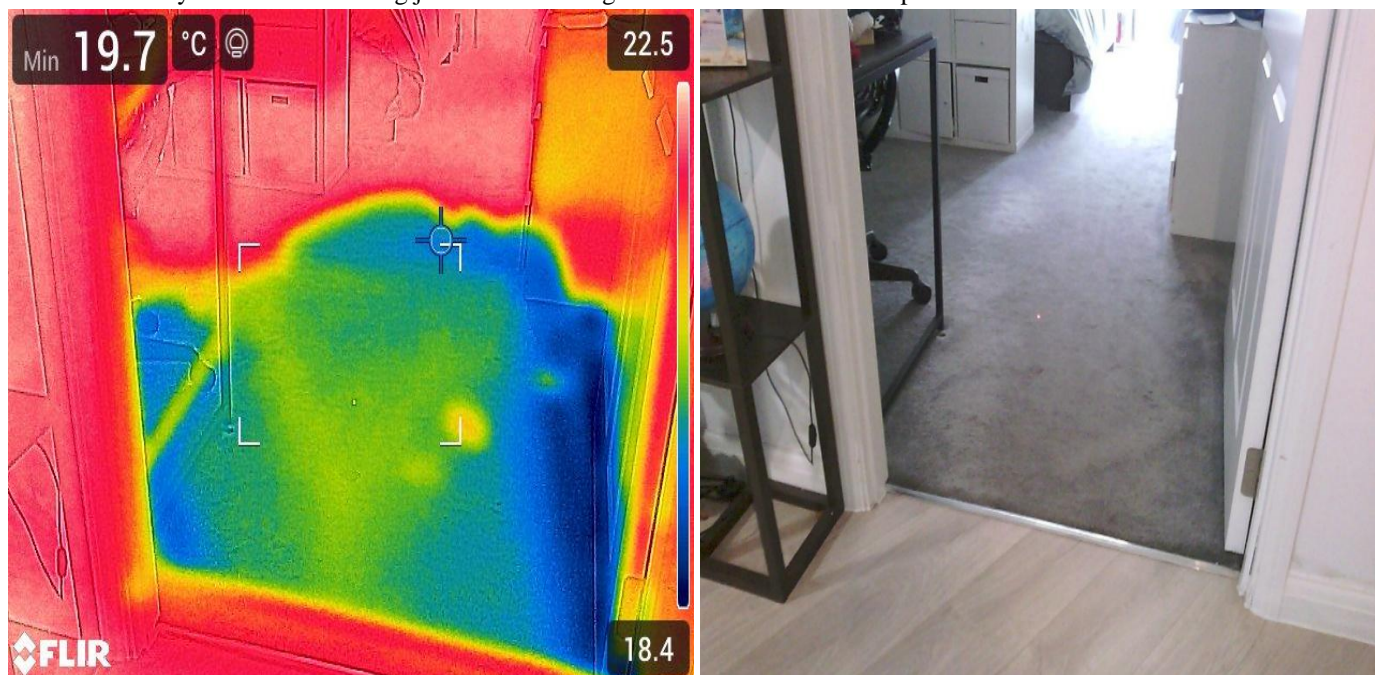
Thermal anomaly at floor and skirting junction indicating moisture accumulation in part of the floor and lower walls.

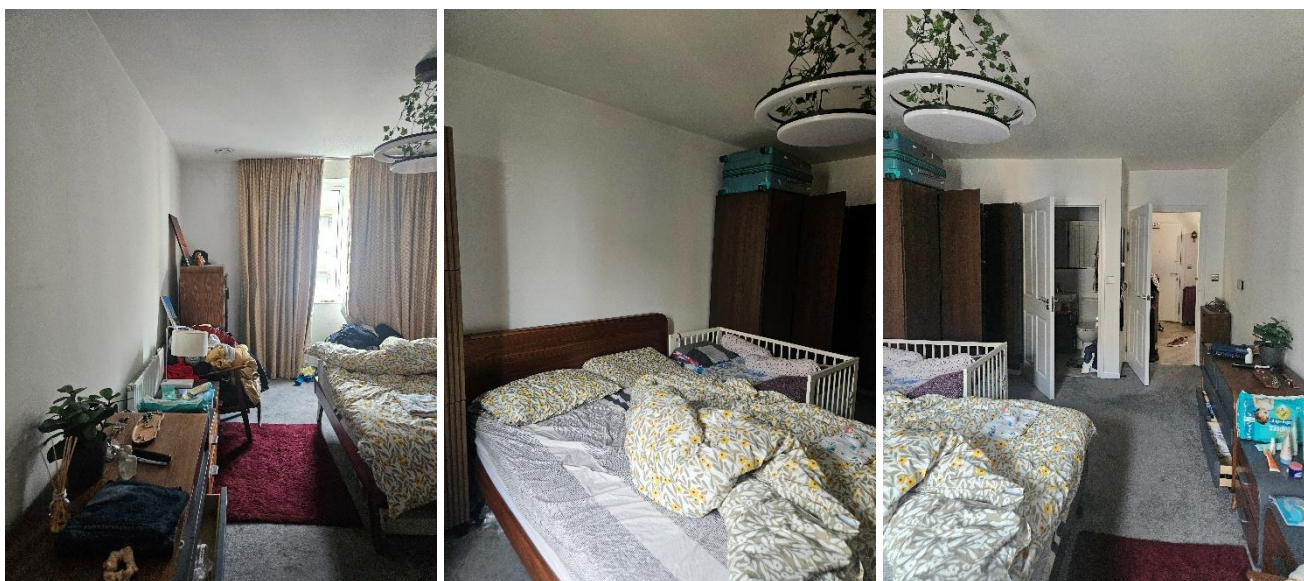
- Localised swelling and fracturing of the door frame and associated architrave elements.
- Moisture-induced distortion and expansion of skirting boards.
- Approximately 5%-10% of the carpeted area was found to be heavily saturated, exhibiting signs of prolonged water exposure.

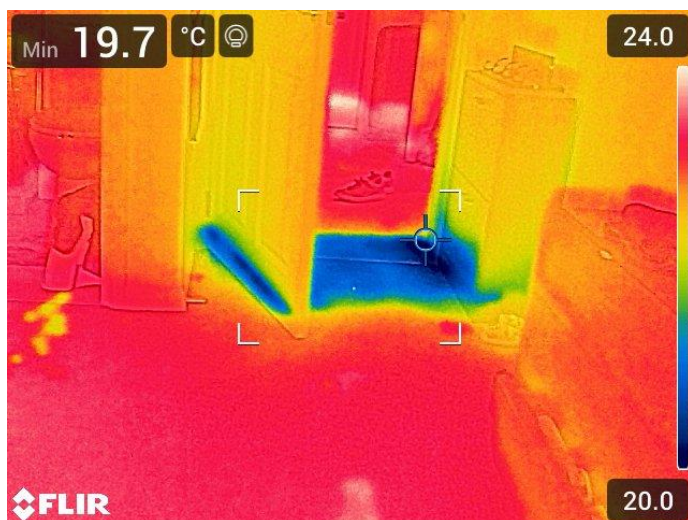
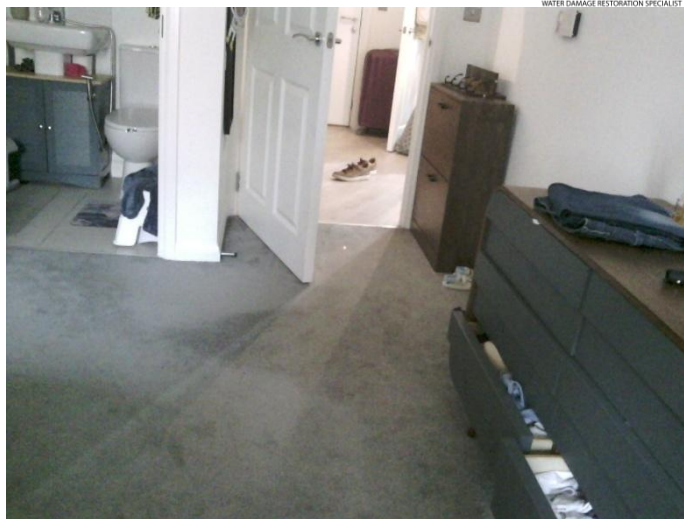
Similar to as in Bedroom 1, we have noted thermal anomaly at floor and skirting junction indicating moisture accumulation in part of the floor and lower walls.

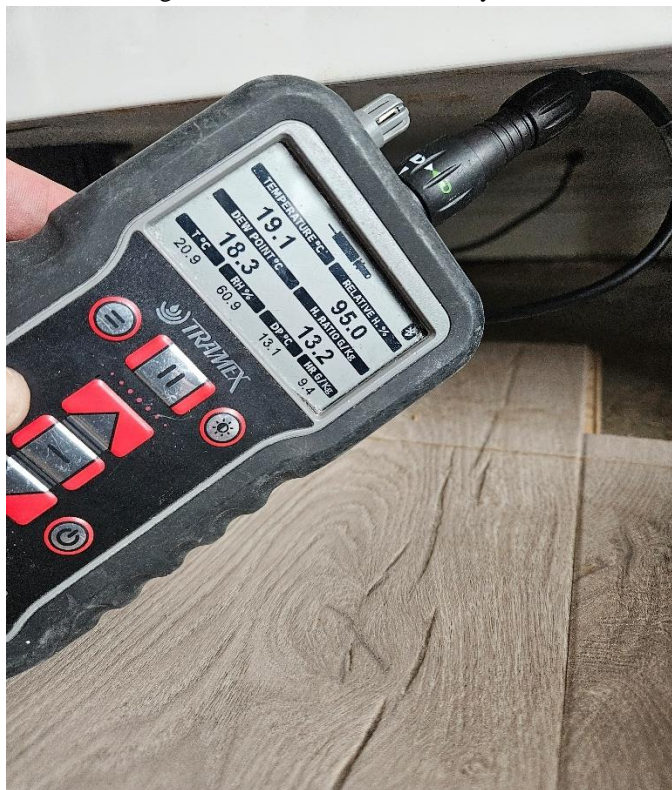
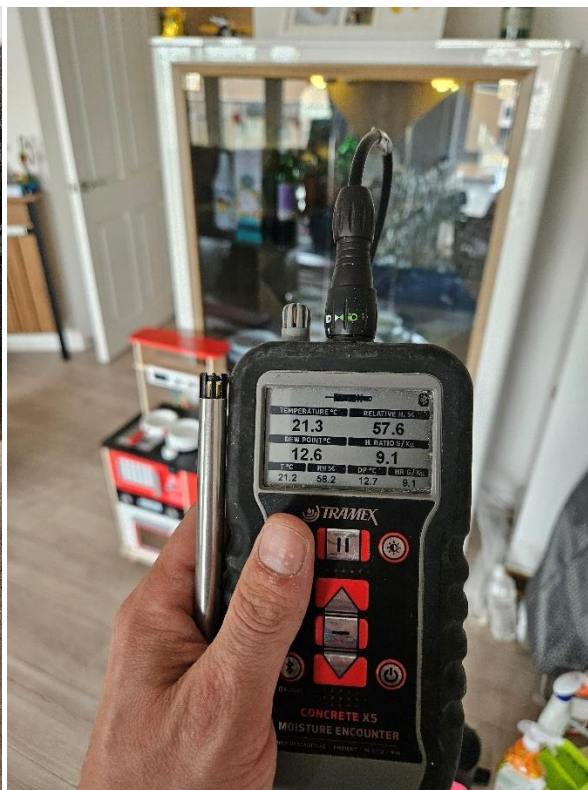
RH1 – Reading obtained from the wall cavity behind the units. Flat 6 – Ambient Conditions

A moisture reading taken at Sample Point RH1—located within the wall cavity behind the kitchen unit at the point of known water escape—recorded a temperature of 19.1°C, with a relative humidity (RH) of 95.0% and rising. The corresponding dew point temperature was 18.3°C, and the specific humidity measured at 13.2 g/kg (also increasing).

The markedly elevated RH and specific humidity within the wall cavity—both of which were rising—are indicative of trapped moisture in the concealed void. The proximity of the measured dew point (18.3°C) to the actual cavity temperature (19.1°C) suggests the internal surface conditions are nearing saturation, with a high risk of continued condensation and further microbial activity if not adequately dried.

These results confirm the presence of retained moisture within the wall cavity and support visual findings of early-stage microbial growth. Proactive moisture control and targeted cavity drying are recommended to prevent further material degradation and microbial proliferation.
