FLOOD | DOCTOR
WATER DAMAGE RESTORATION SPECIALIST

PRELIMINARY REPORT

The purpose of the inspection was to assess the extent of water damage resulting from an escape-of-water (EOW) incident originating within the kitchen area.

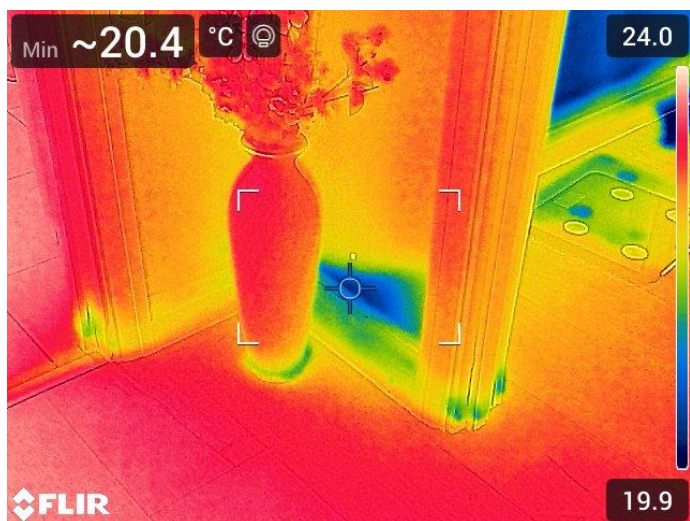
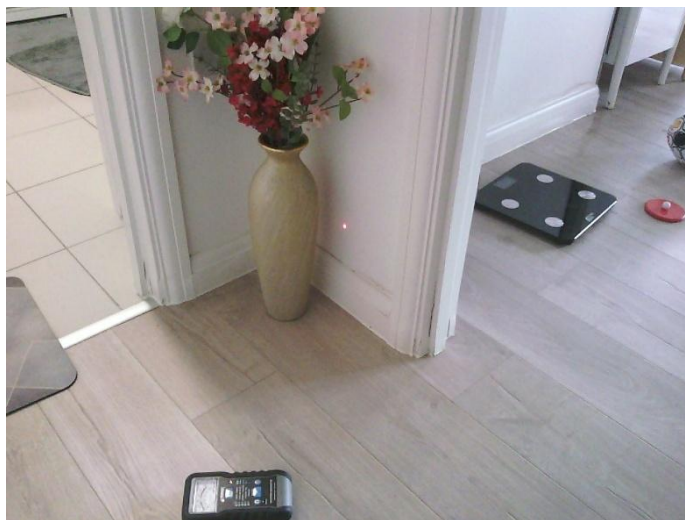
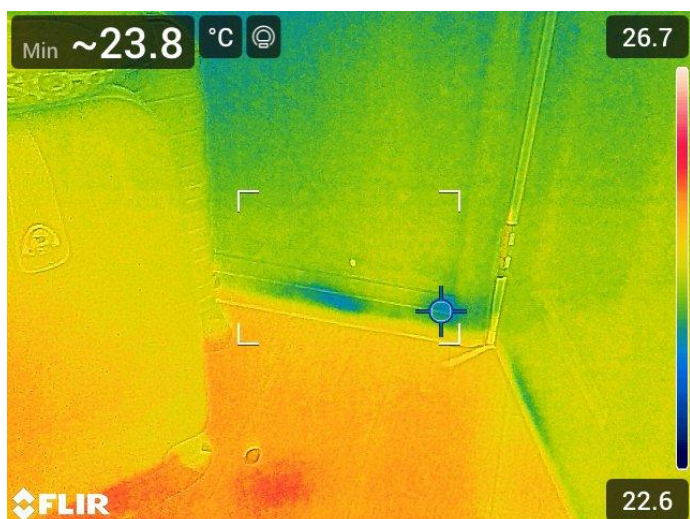
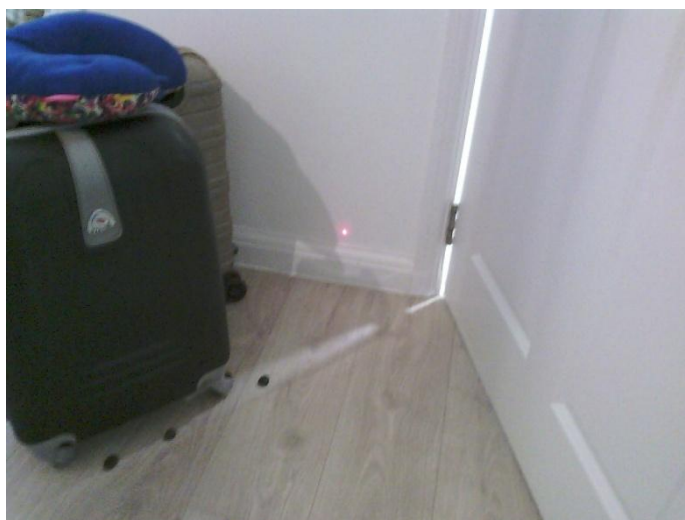
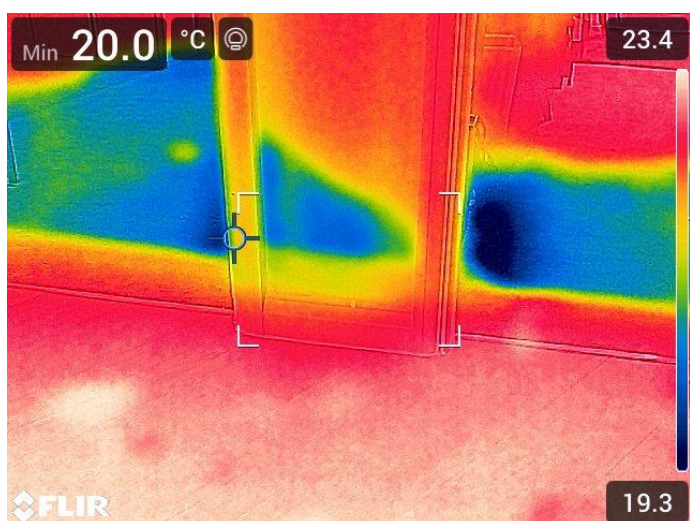
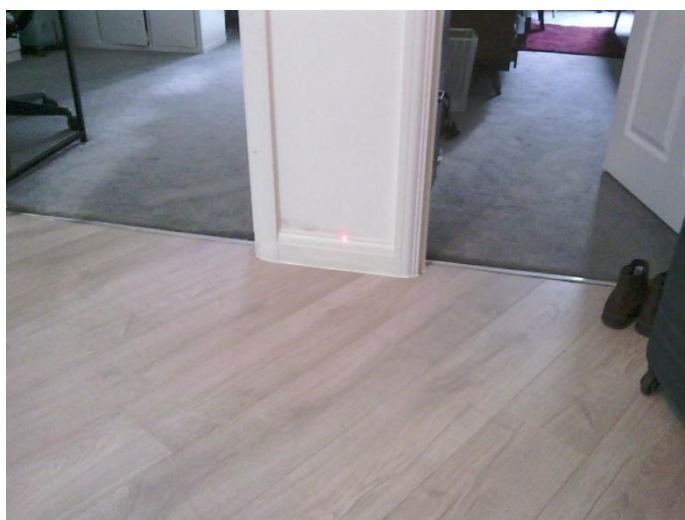
Hall – Thermal Imaging Inspection

We have also noted that virtually all door frames and architraves in the hallway area sustained water damage at a low level (swelling, cracking & paint peeling).

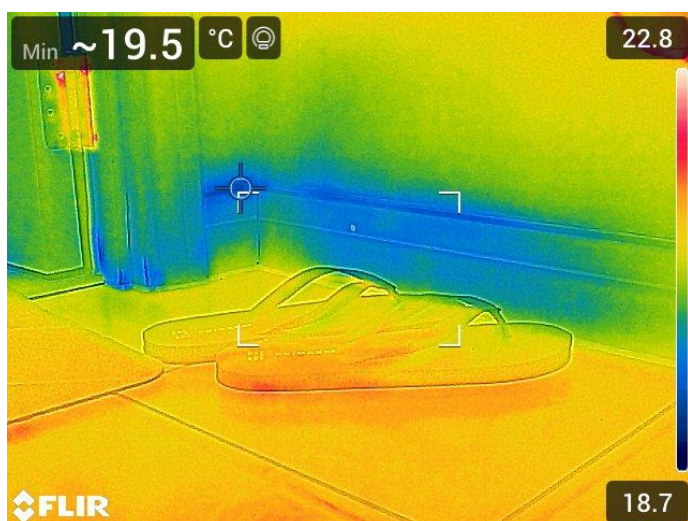
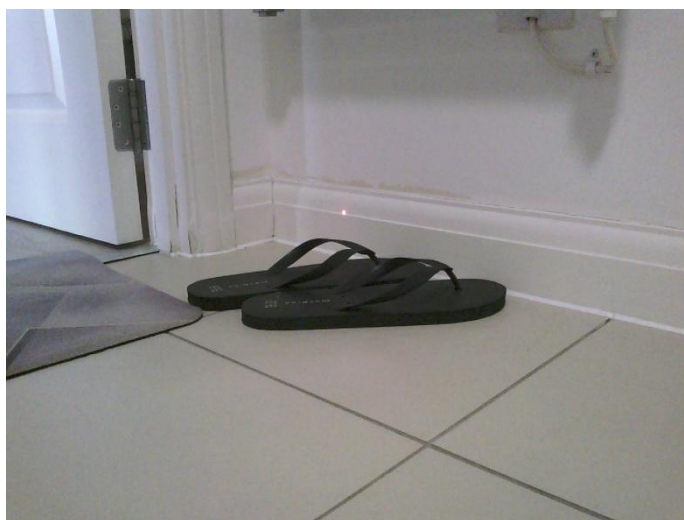
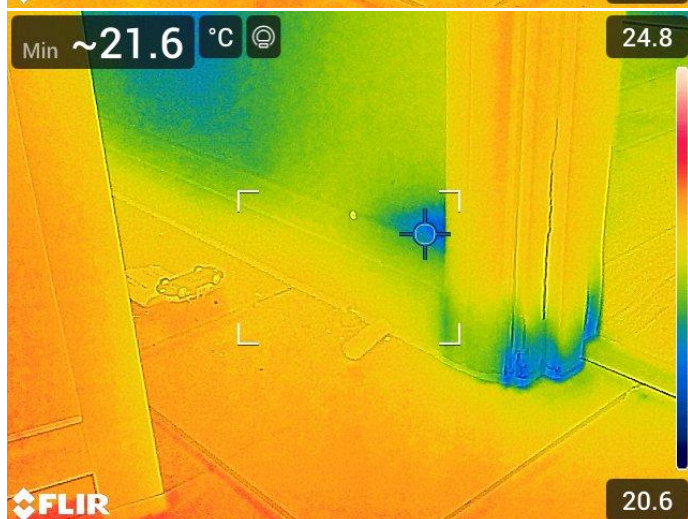
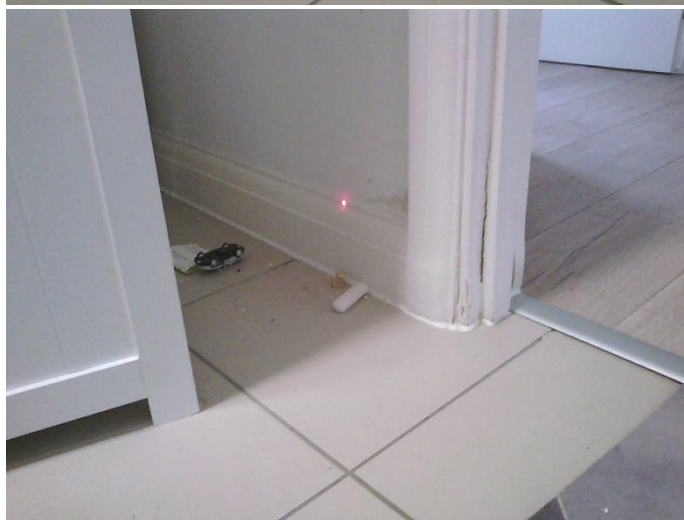
Bathroom – Thermal Imaging Inspection

Swelling & debonding of the skirting board, staining of the lower wall`

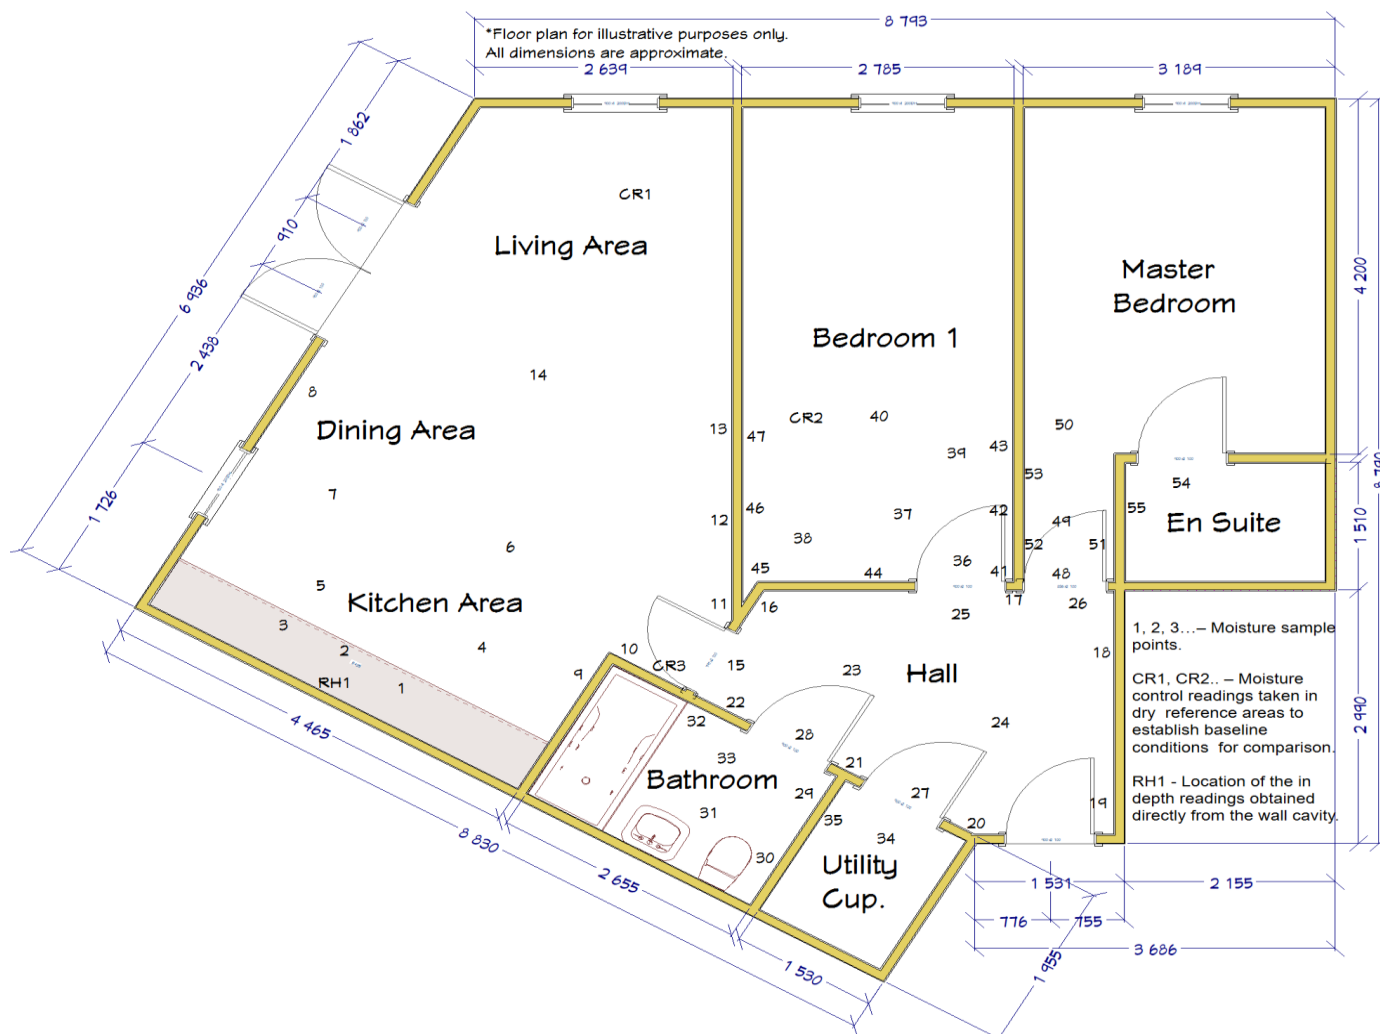
Sample Point	Location / Material	Moisture Reading
CR1	Floor / Laminate	30PS
CR2	Floor / Carpet	8.7% WME
CR3	Wall / Plasterboard	20PS
1.	Floor / Screed	6.9% MC (Max. Reading)

2.	Floor / Screed	6.9% MC (Max. Reading)
3.	Floor / Screed	6.9% MC (Max. Reading)
4.	Floor / Laminate	100 PS
5.	Floor / Laminate	100 PS
6.	Floor / Laminate	100 PS
